HERITAGE AGREEMENT

ROYAL GEORGE HOTEL

(HCWA Place No. 794)

Royal George Hotel 34 Duke Street East Fremantle

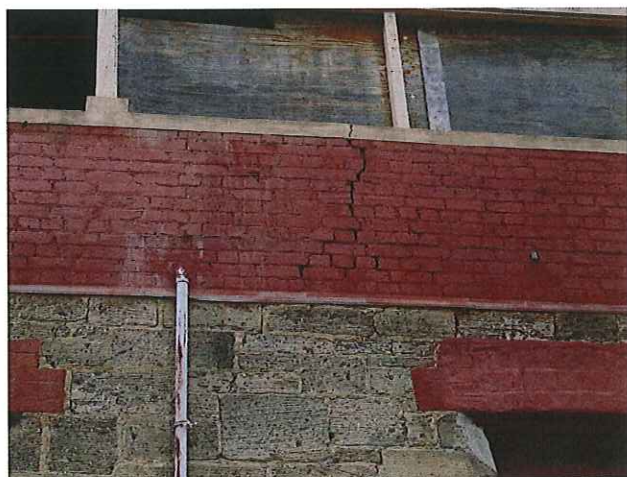
Fig 1. Detail of cracking to brickwork band to north elevation (TPG)

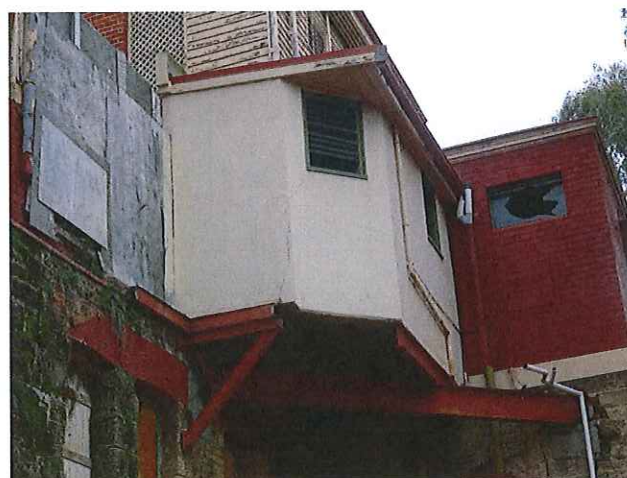
Fig 2. Cantilevered extension to north elevation (TPG)

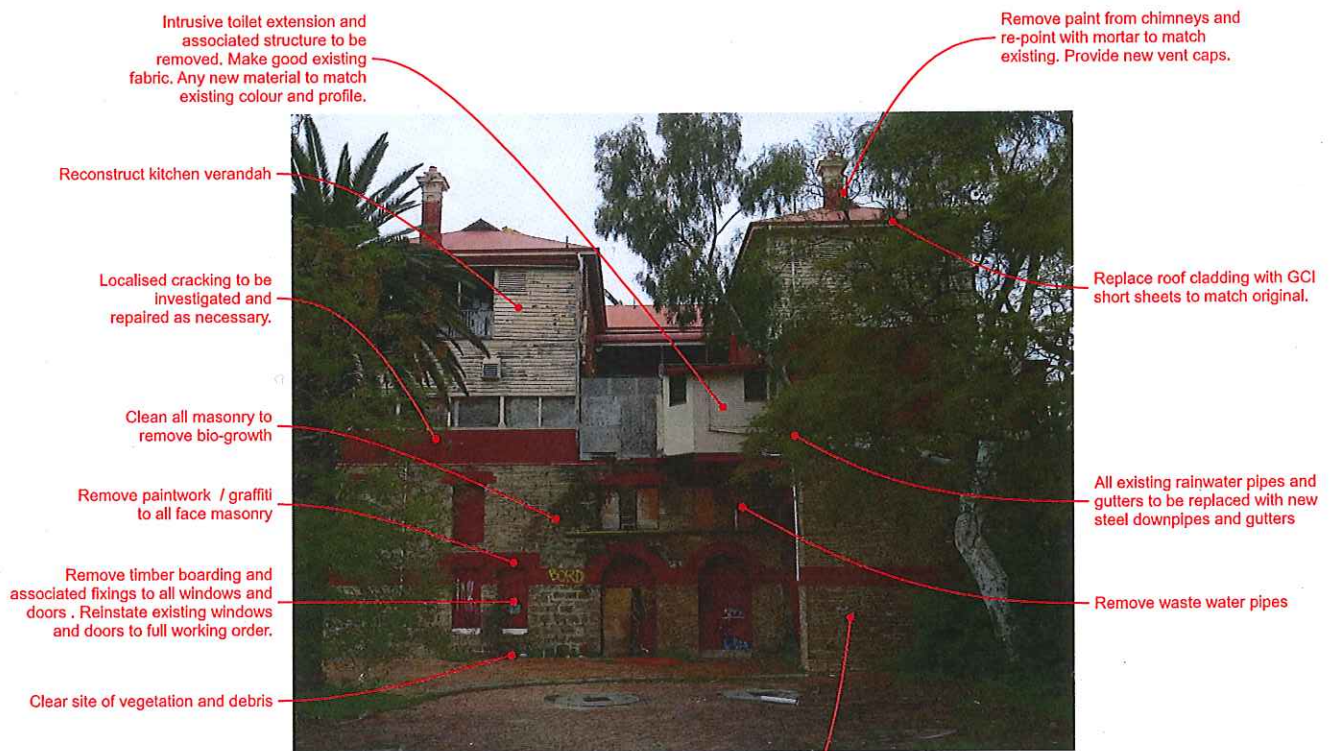
Fig 3. View of North Elevation (TPG)

Re-point eroded / missing mortar joints to masonry with new mortar to match existing colour and performance. Replace stone masonry units where eroded (approx 10no.)

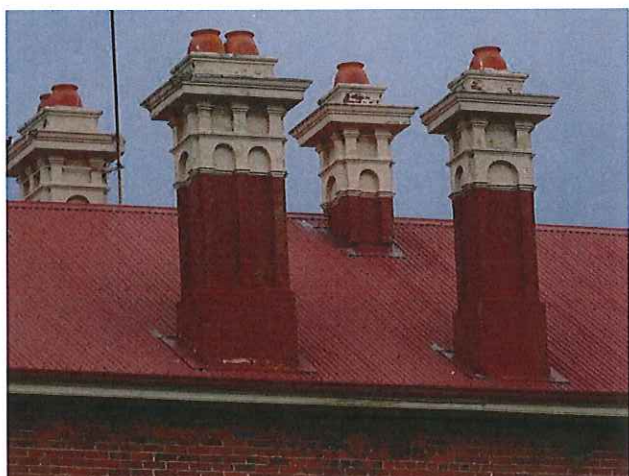
Fig 5. Detail view of chimneys - east elevation (TPG)

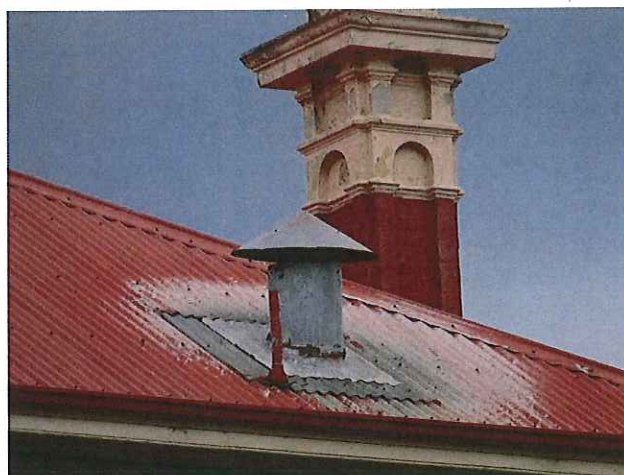
Fig 7. View of corrugated roof sheets - east elevation (TPG)

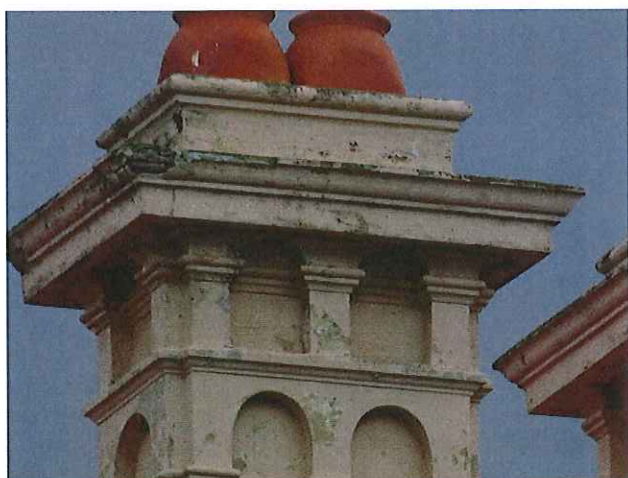
Fig 6. Detail view of chimney pediment - east elevation (TPG)

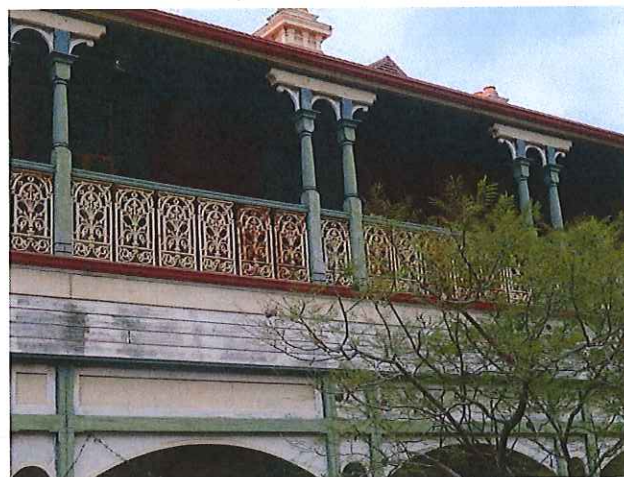
Fig 14. Detail view of first floor verandah - south elevation (TPG)

Reconstruct column bases to verandah. Strip and repaint all painted finishes, repair & oil all floorboards.

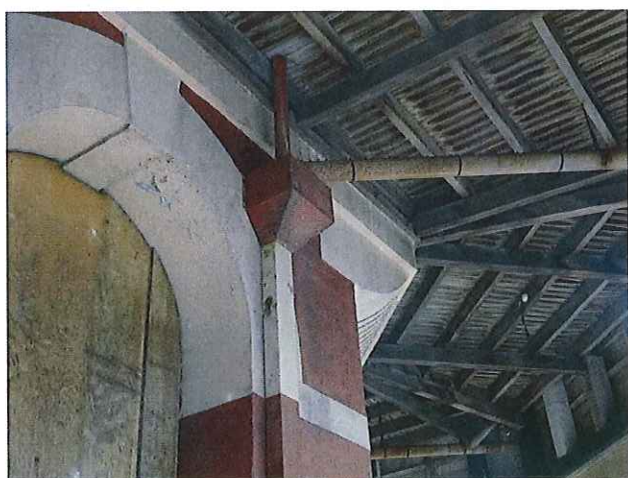
Fig 12. Detail view of u/s of verandah structure (TPG)

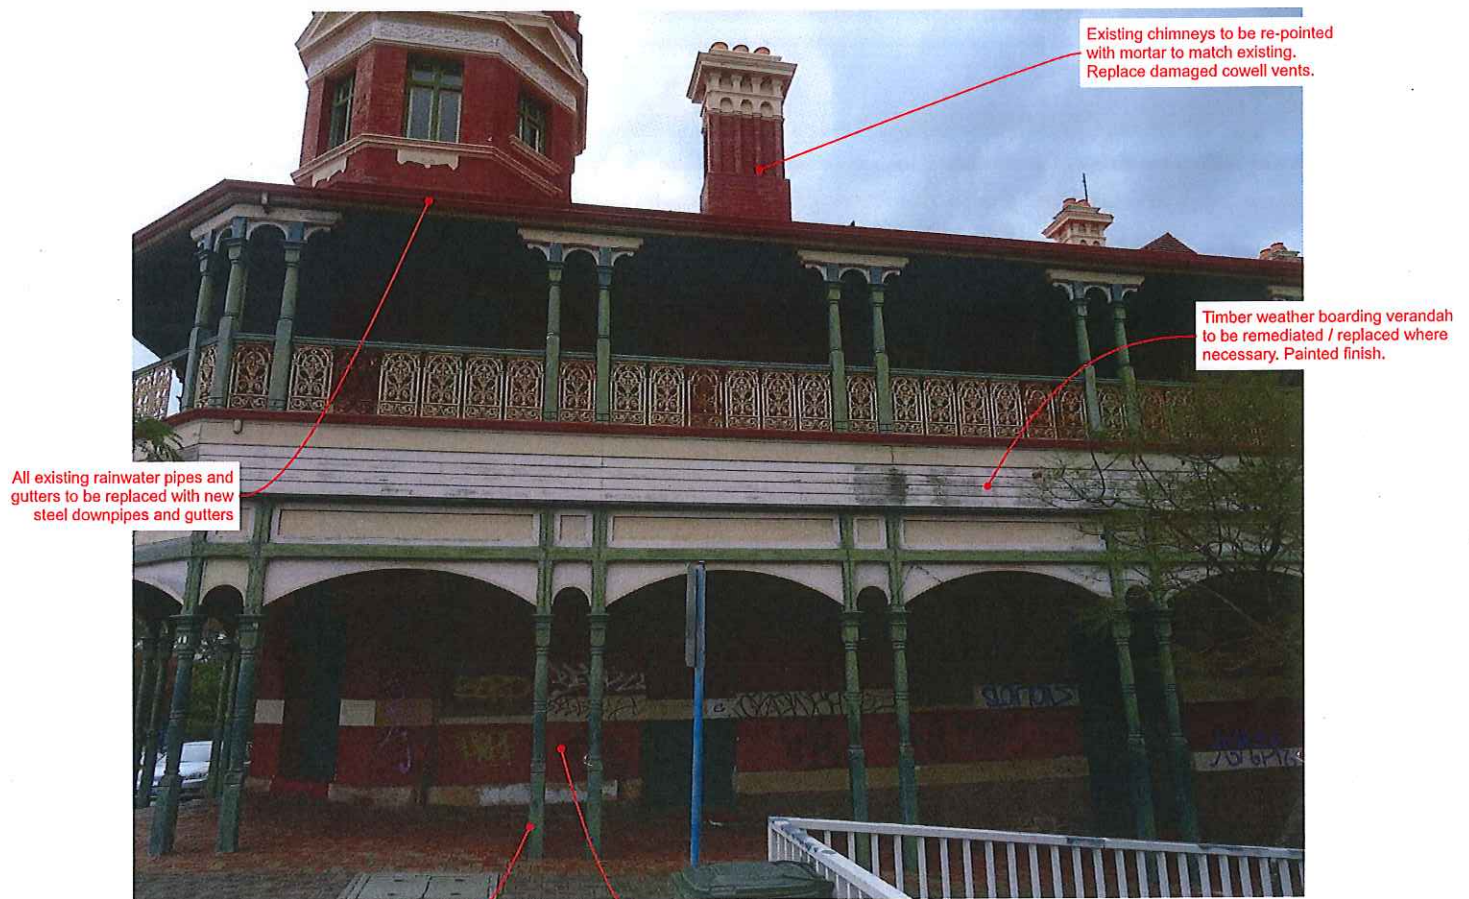
Fig 15. View of South Elevation (TPG)

Clean all masonry to of bio-growth, paint and graffiti.

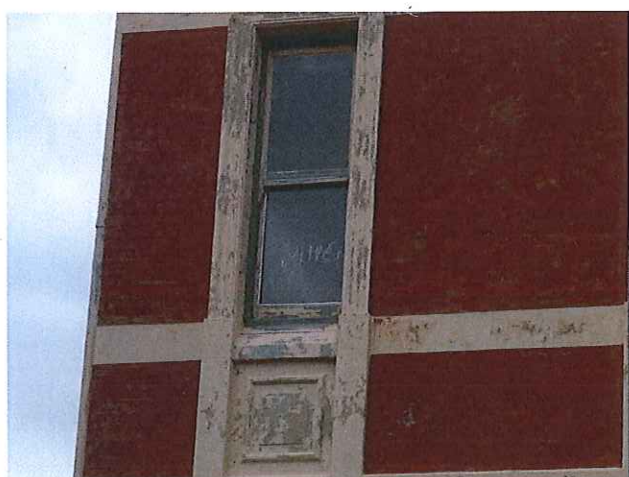
Fig 17. Detail of window surrounds - west elevation (TPG)

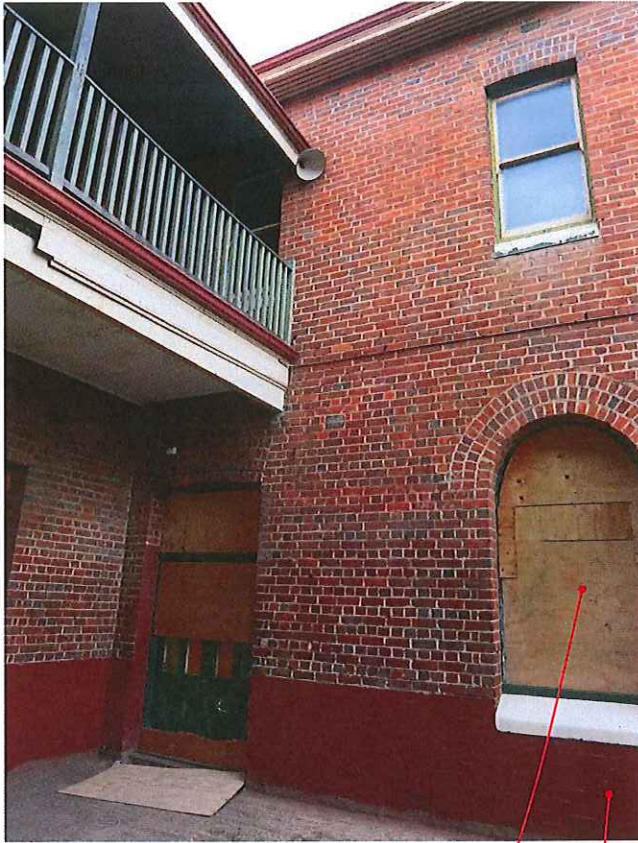
Fig 30. View of Courtyard Elevation - west (TPG)

Remove timber boarding and associated fixings to all windows and doors. Reinstall existing windows and doors to full working order.

Remove paintwork / graffiti to all face masonry

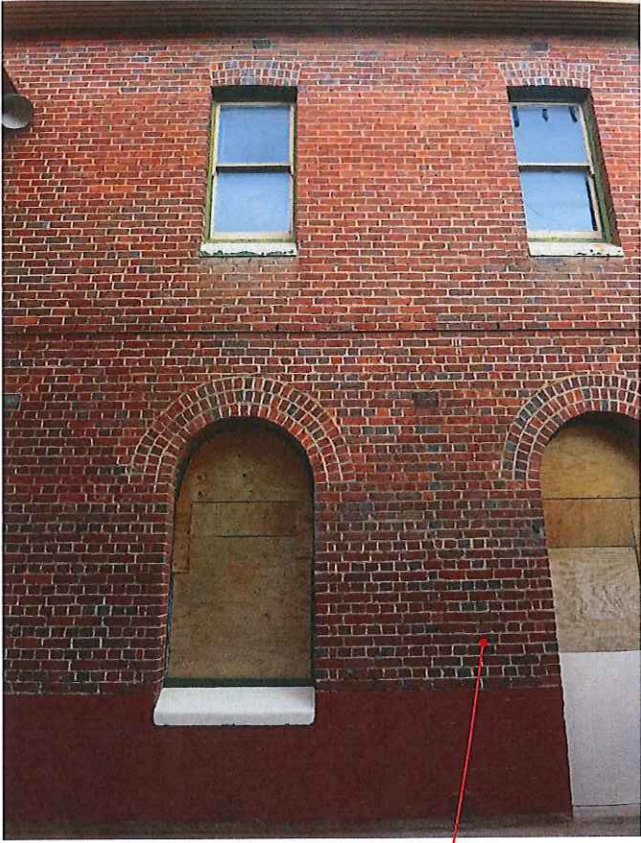
Fig 31. View of Courtyard Elevation - east (TPG)

Re-point eroded / missing mortar joints to masonry with new mortar to match existing colour and performance.

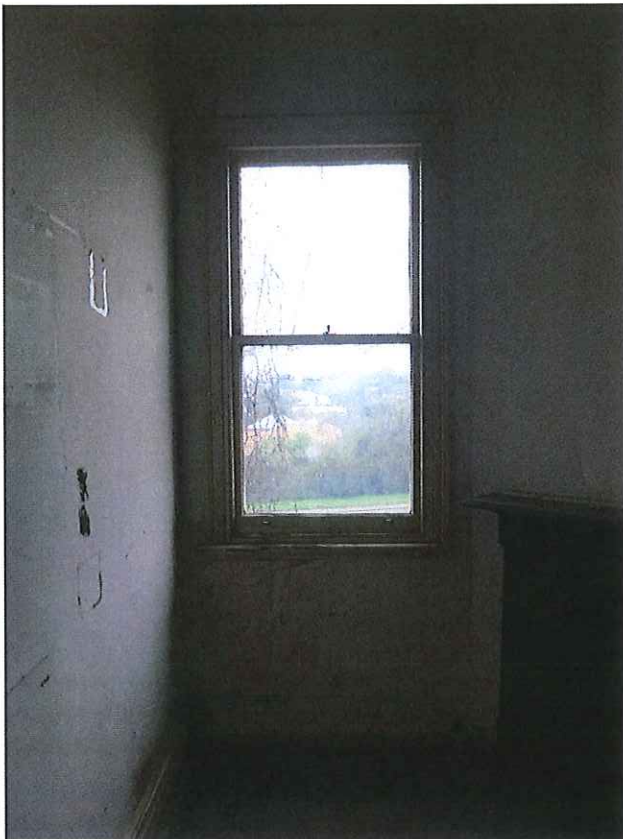
Fig 48. Room G05 - Water damaged window cill and plaster (TPG)

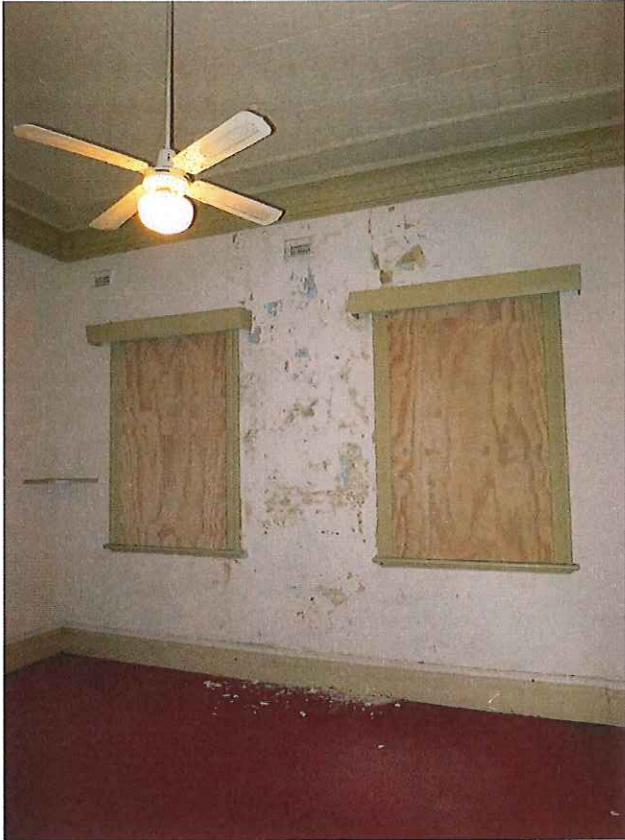
Fig 50. Room R4 - Water damaged plaster (TPG)

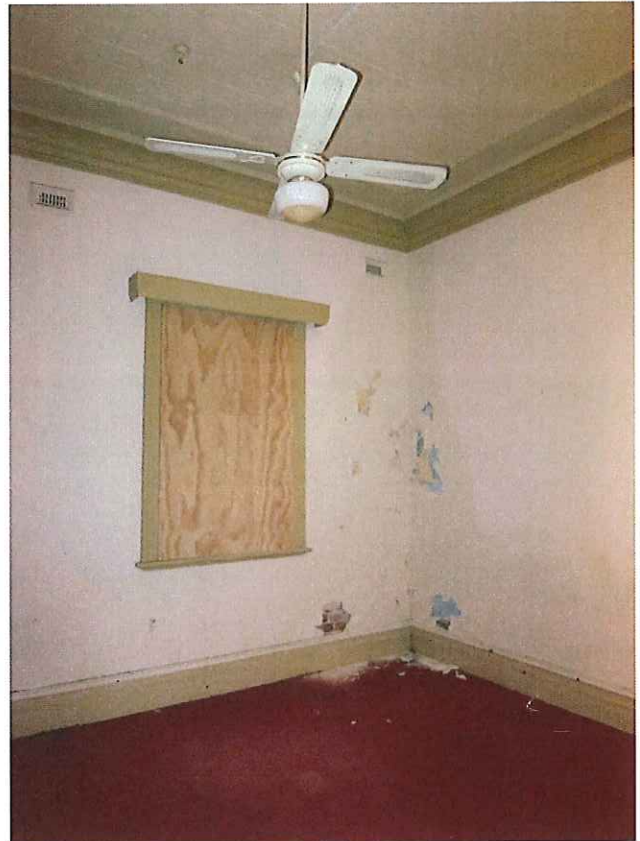
Fig 51. Room R4 - Water damaged plaster (TPG)

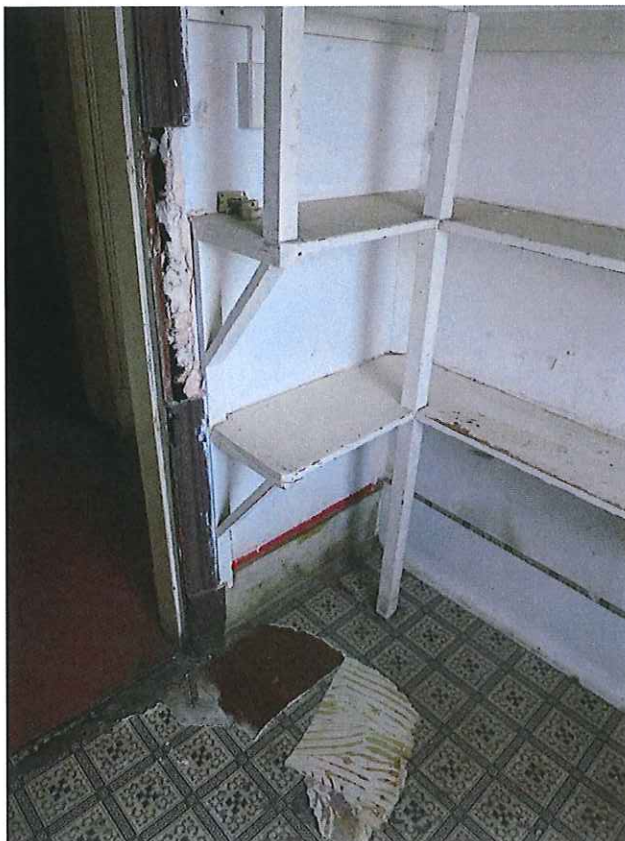
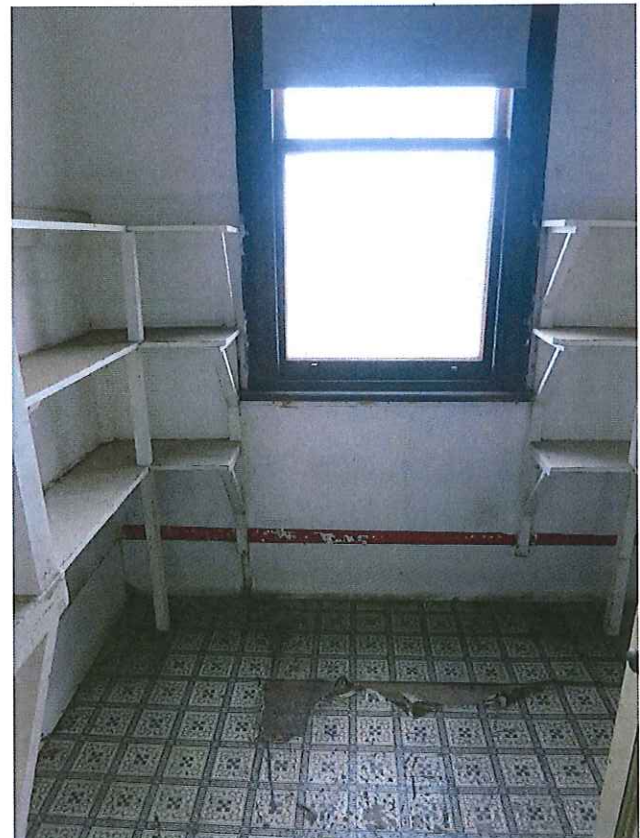
Fig 52. Room R6 (TPG)

Room R6	C	Generally in fair to poor condition.	Remove fixtures and fittings. Make good wall finishes. Remove floor finish. Parts of door frame to be replaced with new to match existing.	All	3
Room R7 - Kitchen	C	Generally in fair to poor condition.	Remove wall tiles, pipework and redundant fixtures and fittings. Make good floor and wall finishes.	All	3
Room R8 - Ceiling	C/D	Collapsed ceiling.	Cut away damaged ceiling and replace with new plasterboard and make good. Any defective ceiling joists to be replaced. Painted finish.	Item	2
Female WCs	E	No access but visibly in poor condition and is considered intrusive to the original fabric.	To be removed and original fabric to be made good to match existing.	Item	3

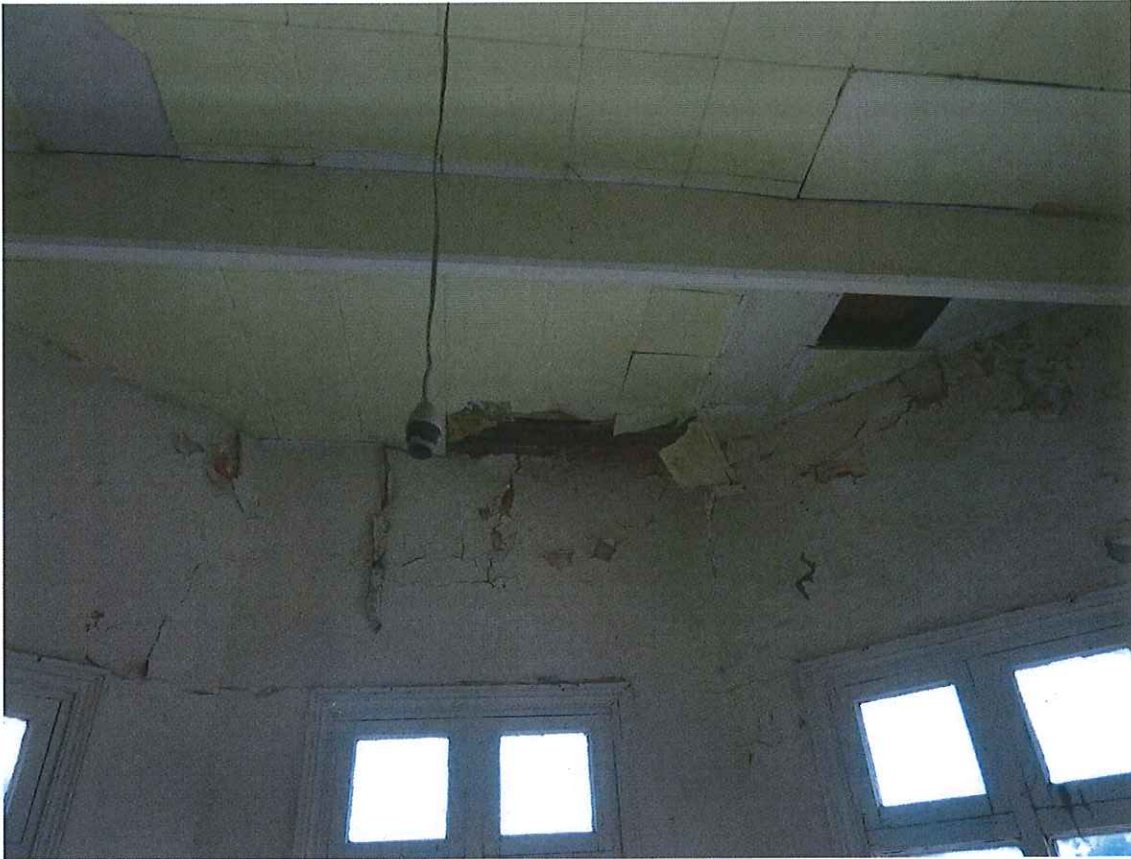
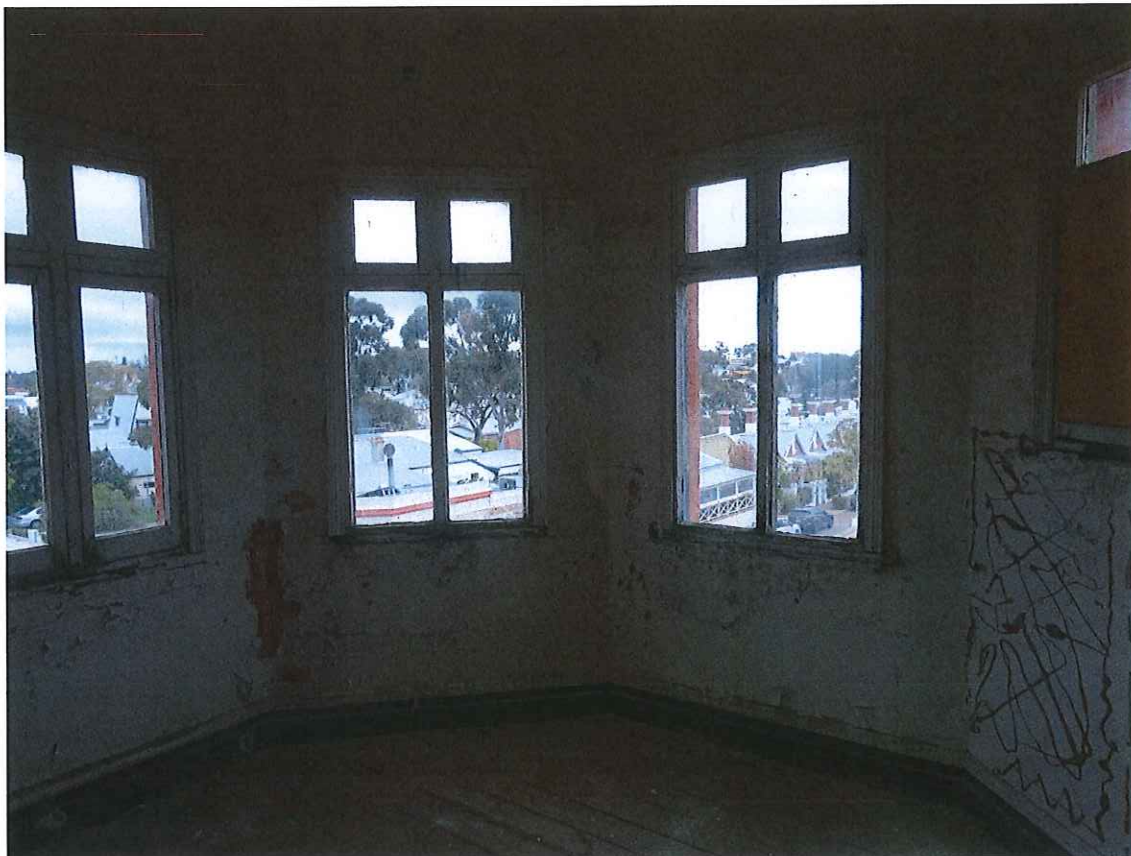
Fig 57. Cupola Room (TPG)

Element	Condition Rating	Comment on Condition	Remediation Works	Extent	Priority Rating
Cupola Room - Ceiling	E	Ceiling in poor condition with signs of water ingress.	Investigate source of water damage and rectify. Any defective ceiling joists to be replaced. Remove existing ceiling tiles and re-construct lath and plaster ceiling. Painted finish.	All	2
Cupola Room - Walls	E	Existing wall plaster in very poor condition with cracking throughout.	Investigate source of cracking, allow for potential replacement of corroded wall ties. Refer to Wood & Grieve's Electrical and Structural Assessment (2007). Remove and re-construct lath and plaster walls. Painted finish.	All	2
Cupola Room - Floor	D	Slight decay of floor boards around perimeter of room.	Replace any deteriorated boards.	10%	3
Cupola Room - Windows	D	In poor condition with signs of water damage.	Repair or replace all decayed window lintels, frames, cills and sashes. Painted finish.	100%	2

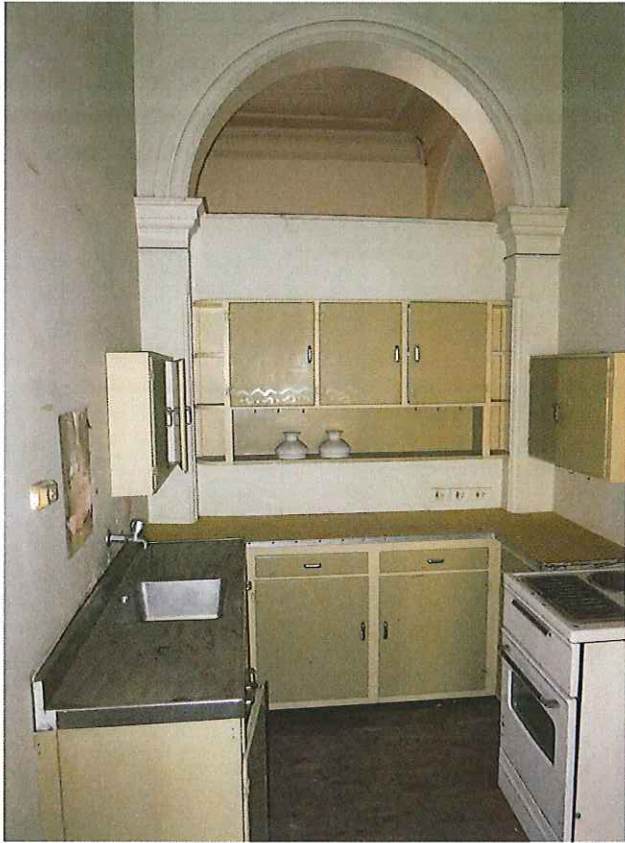
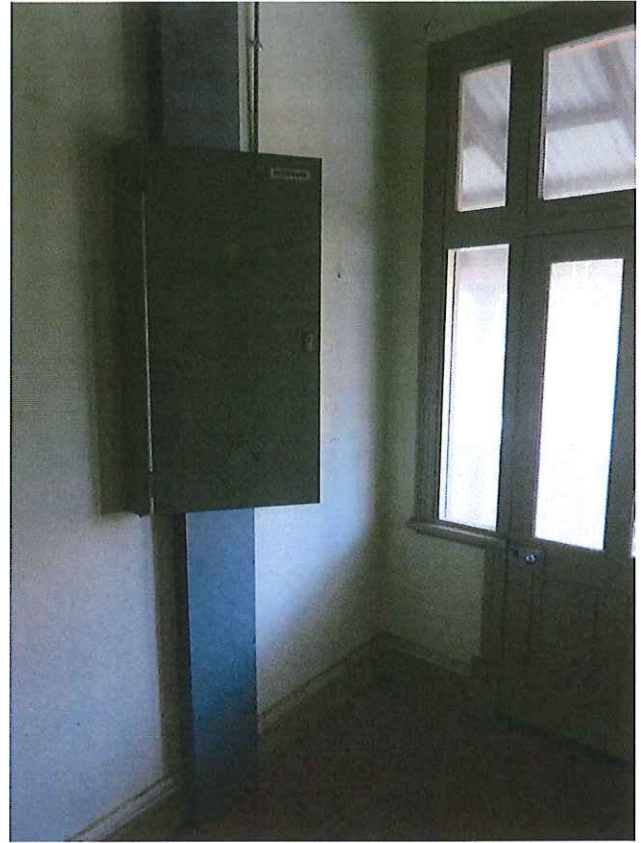
Fig 62. Room R20 - Kitchen (TPG)

Room 20 - Kitchen	C	In fair condition but is considered intrusive to the original fabric.	Remove kitchen and restore opening to south passage. Reconstruct as a hallway and provide cabinet enclosure to switchboard.	Item	3
