HERITAGE  
COUNCIL  
OF WESTERN AUSTRALIA

## REGISTER OF HERITAGE PLACES Supporting Information

Figure 1: Site Plan of P27015 Customs House and Sub-Collector's Residence, Broome. Dar Studio, June 2023.

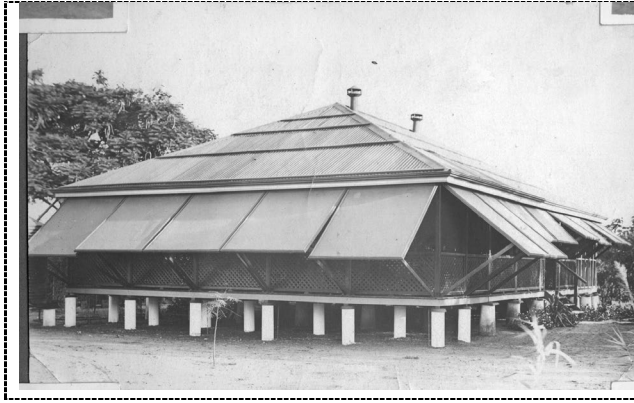
**Figure 3. The residence of the Customs Officer (Sub-Collector's Residence), c. 1925 after verandah renovations.**

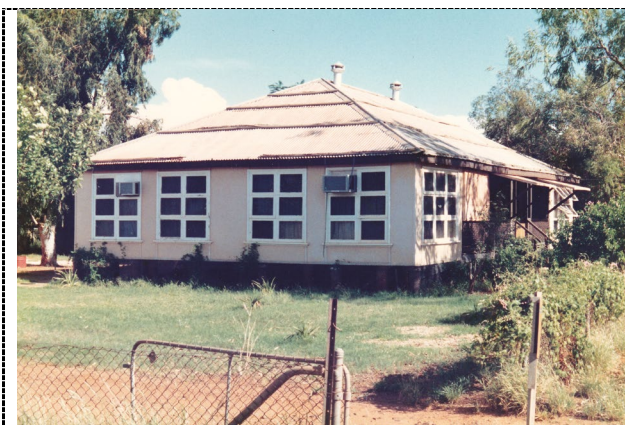
**Figure 5. Customs residence (Sub-Collector's Residence) while in private ownership, c. 1985.**

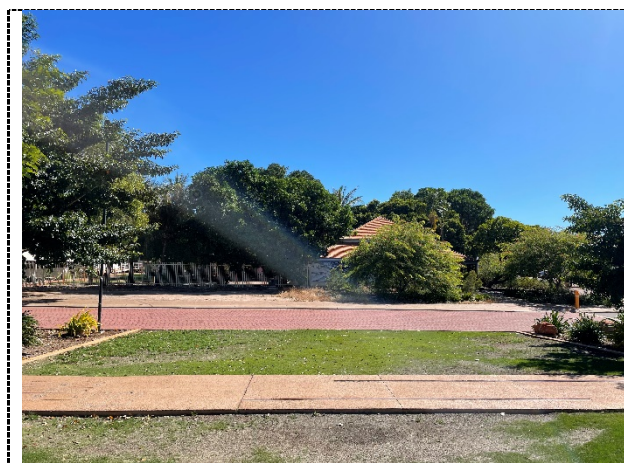
**Figure 6. East elevation view of Customs House from Hamersley Street.**

Much of the site, when viewed from the surrounding streets, is obscured by mature trees and tropical plantings.

Left of the former Customs House is the State Registered Place P5250 *Sailmaker's Shed (fmr)*, Broome, which is not within the curtilage of *Customs House and Sub-Collector's Residence, Broome*.

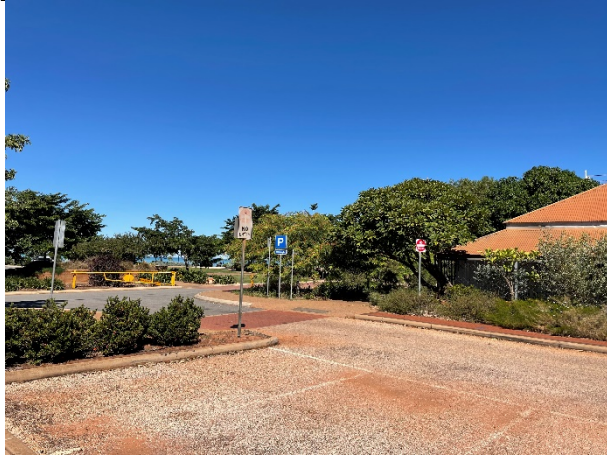
**Figure 7. Part north elevation view of Customs House.**

A small shopping centre carpark and access road is north of the former Customs House.

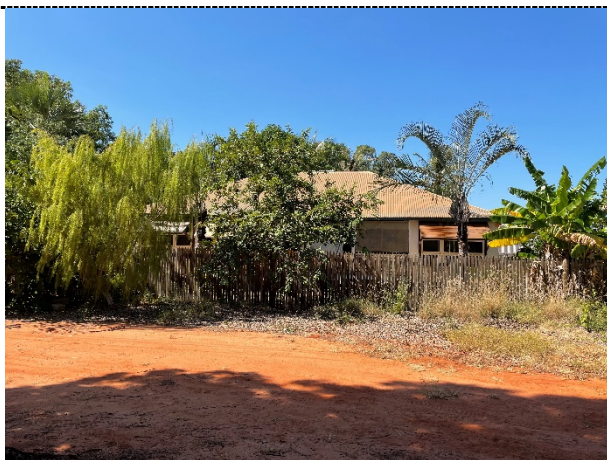
**Figure 9. West elevation view of Sub-Collector's Residence from Robinson Street.**

The former Sub-Collector's Residence is setback from the street behind a timber fence and is partly obscured by plantings.

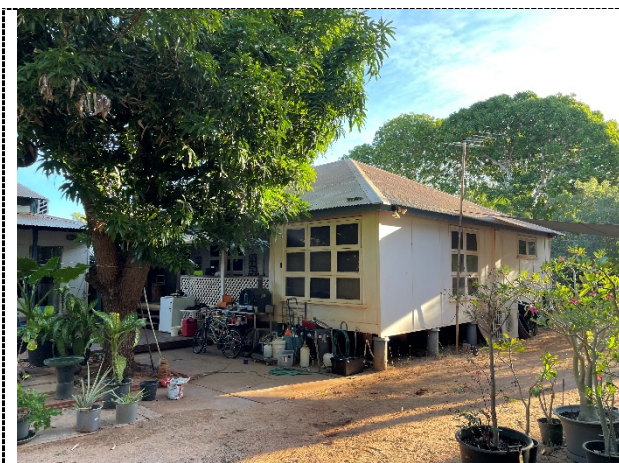
**Figure 10. Driveway and rear yard to Sub-Collector's Residence.**

To the rear is a mature mango tree and an addition to accommodate a bedroom and laundry (c.2012), to the left of this image.

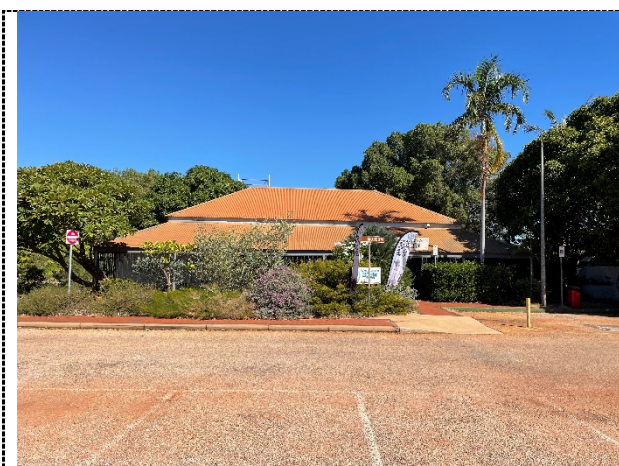
**Figure 11. Customs House - view of front (north) elevation.**

The main roof is of hipped profile configuration with a separate hipped verandah of the same pitch, all covered with corrugated metal in long sheet sections with a factory pre-painted finish.

There are no gutters or downpipes to either the main roof or verandah, which is typical for this region with all stormwater discharging to ground.

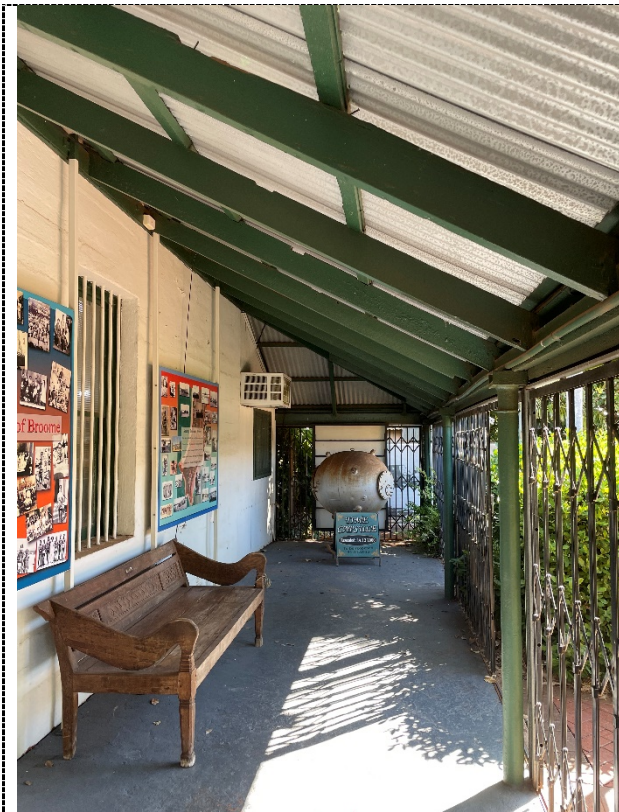
**Figure 12. Customs House - view of front verandah looking west.**

The external walls are built from off-form concrete, otherwise referred to as 'in-situ' or 'site-cast', with horizontal timber boarding used as formwork, which now has a white painted finish.

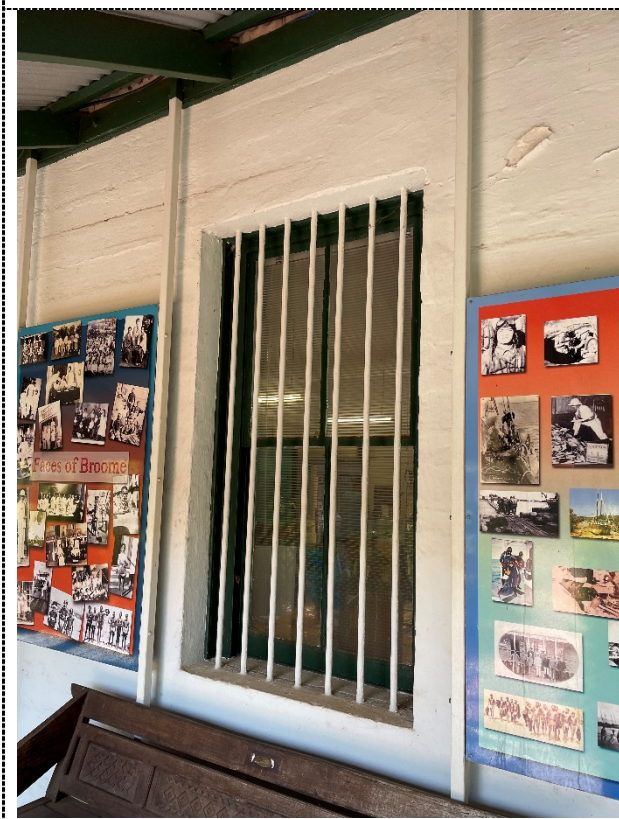
**Figure 13. Customs House - typical window to north façade.**

Windows are symmetrically placed around the building and are painted timber frame double hung sashes. They are a combination of two subtly different styles and sizes with one type being two vertical panes per sash and the other slightly smaller and having two horizontal panes per sash.

All original windows have external painted vertical steel bars embedded in the concrete reveals.

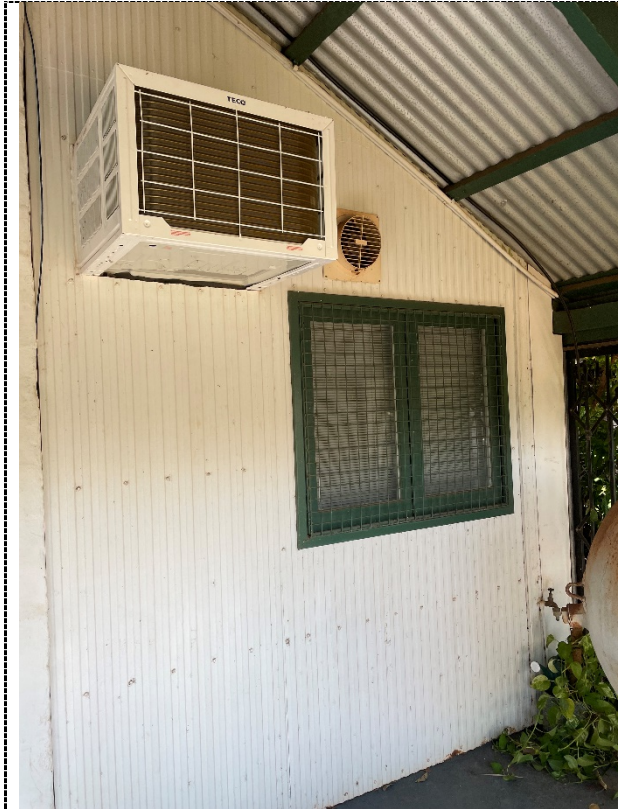
**Figure 14. Customs House - detail of enclosed verandah to north façade.**

The verandahs are enclosed on the east, south, and west facades with vertical, white pre-painted corrugated steel sheeting. There are enclosing partitions to the north in the same alignment as the front concrete wall, as shown here.

A later painted timber double casement window has been added to the north façade for the kitchenette.

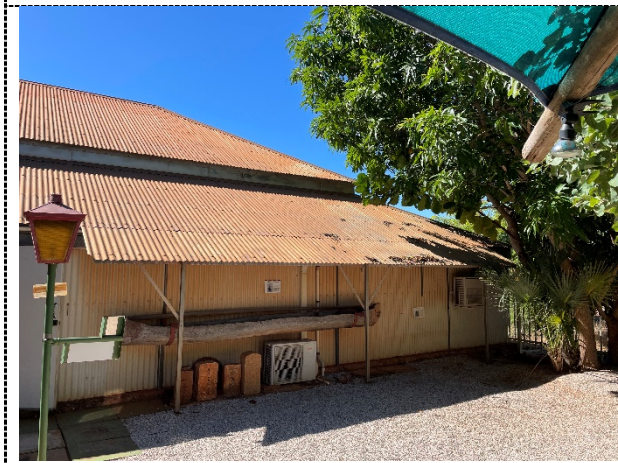
**Figure 15. Customs House - view of south façade.**

The south doors to the rear have been removed and replaced with a roller shutter door. A later set of flat panel steel doors have been added to the enclosed verandah to the south, resulting in the removal of the original cast iron column. This column remains stored on site so could readily be re-instated.

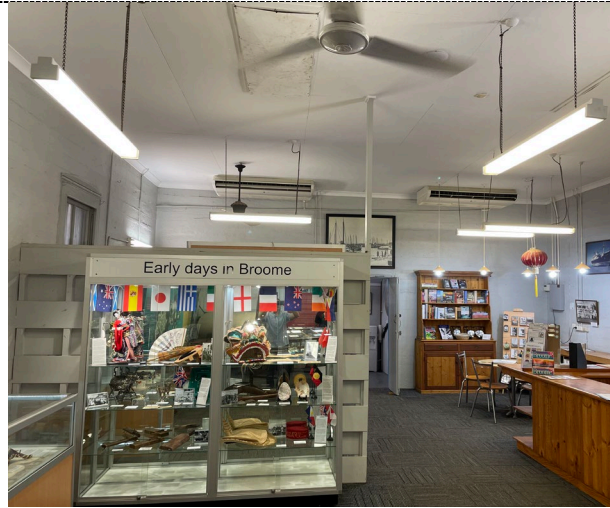
**Figure 16. Customs House - view of main internal museum space.**

The main room is of generous size and characterised by its high ceiling and perimeter window openings. The space is generally fit out with display items and free-standing units associated with the current use as a museum.

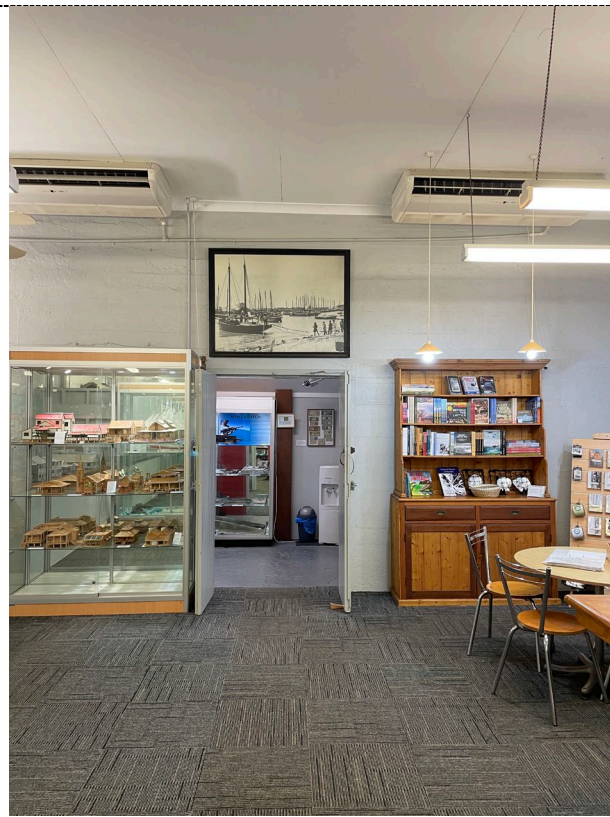
**Figure 17. Customs House - view looking through west wall of main room into enclosed verandah.**

The internal detailing consists of painted concrete walls and modern carpet tiles covering the original concrete floor slab. The ceiling is flat plasterboard sheeting with exposed joints and a small painted cornice trim.

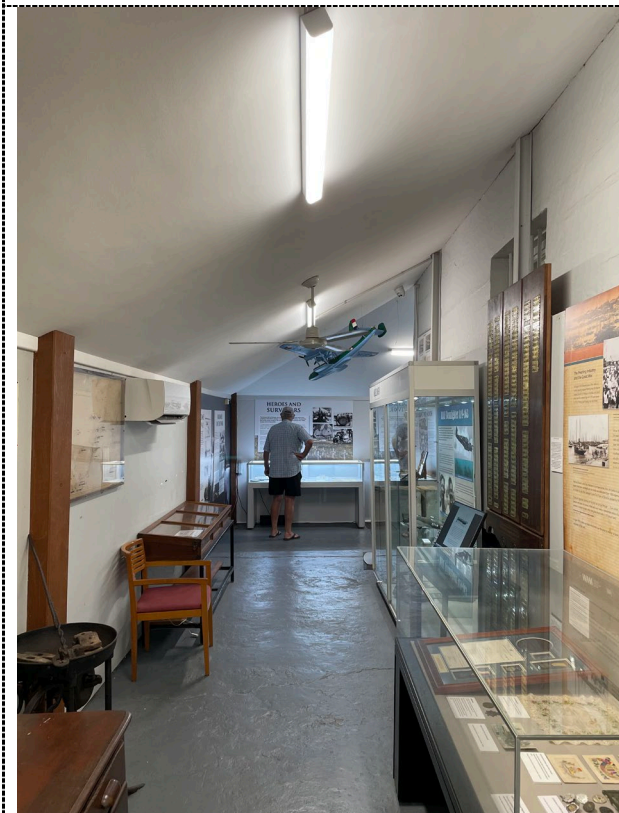
**Figure 19. Customs House - typical internal detail of enclosed verandah.**

All floors have their painted surface exposed that show signs of general wear and tear with unevenness and cracking.

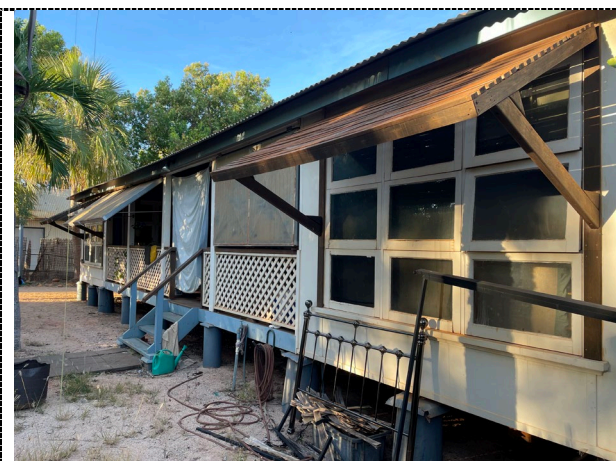
**Figure 20. Sub-Collector's Residence (from c.1910/11) - view of front (west) façade.**

In this image there are two fixed timber awnings and adjustable metal cyclonic shutters to verandah.

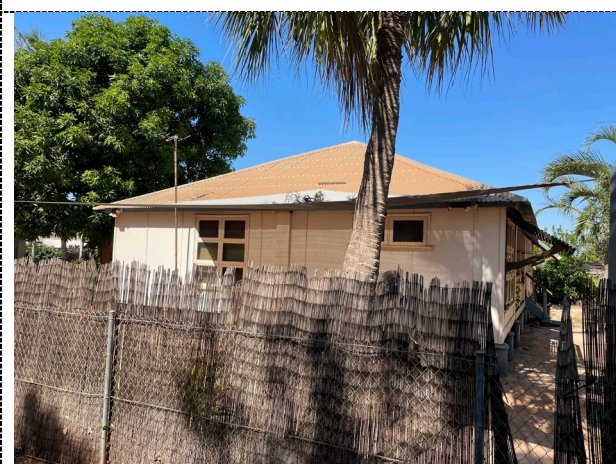
**Figure 21. Sub-Collector's Residence - north elevation view.**

The roof is hipped, clad with pre-painted factory finished corrugated steel sheeting with a painted timber fascia board. Like the former Customs House, there are no gutters or downpipes.

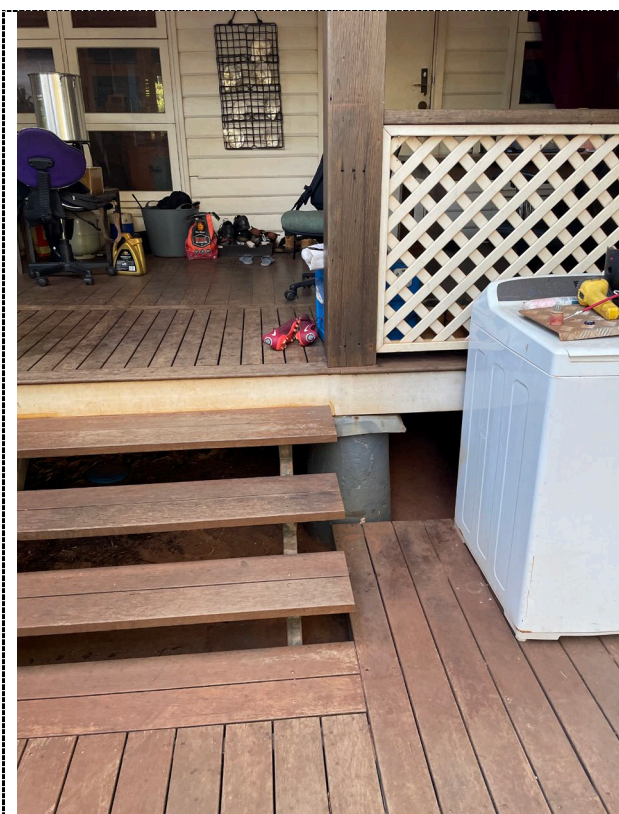
**Figure 22. Sub-Collector's Residence - detail view of rear (east) verandah steps, ground stump, and balustrade.**

The raised timber floor is supported by circular painted concrete ground stumps, which creates approximately 0.5m high void space underneath the building. Metal ant caps are installed to the top of each stump.

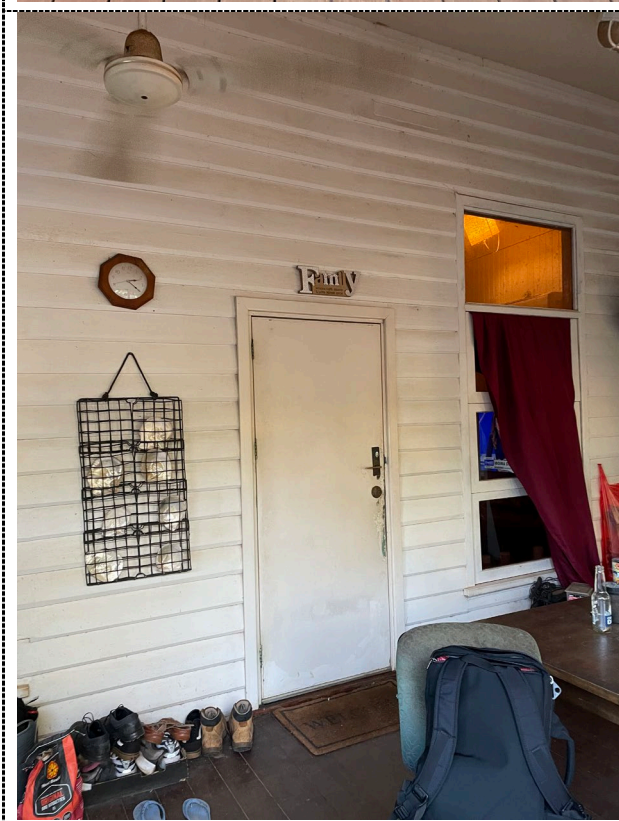
**Figure 23. Sub-Collector's Residence - detail view of rear (east) verandah.**

The timber weatherboard cladding and window appears to be original.

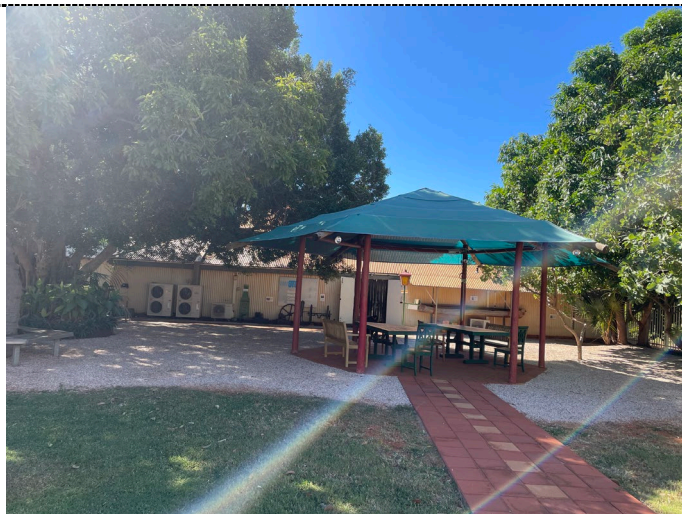
**Figure 27. Gazebo structure to south of Customs House.**

Aligned with the south access opening into Customs House is a timber framed hexagonal gazebo structure built between 1970 and 2000. It has a shade cloth roof covering, and brick paved flooring. The gazebo does not contribute to the significance of the place.

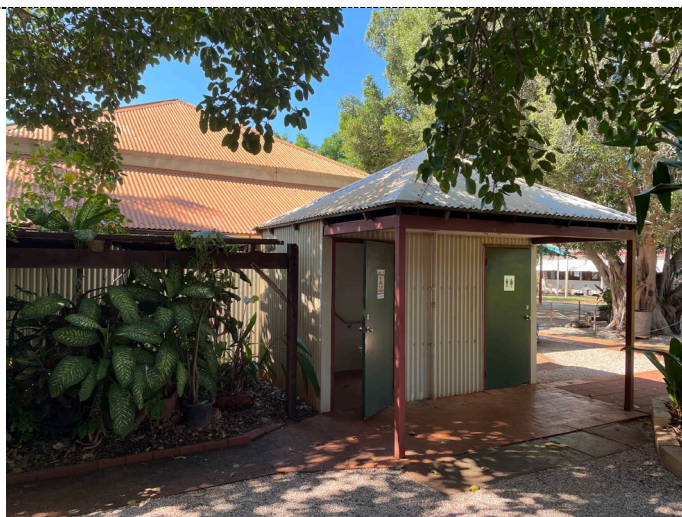
**Figure 28. West elevation view of Ablution block, to the west of Customs House.**

Built between 1970 and 2000, the Ablution Block accommodates two WCs and an undercover area in front. It is a steel frame structure with a hipped roof clad with corrugated steel sheeting to the walls and roof. The Ablution block does not contribute to the significance of the place.

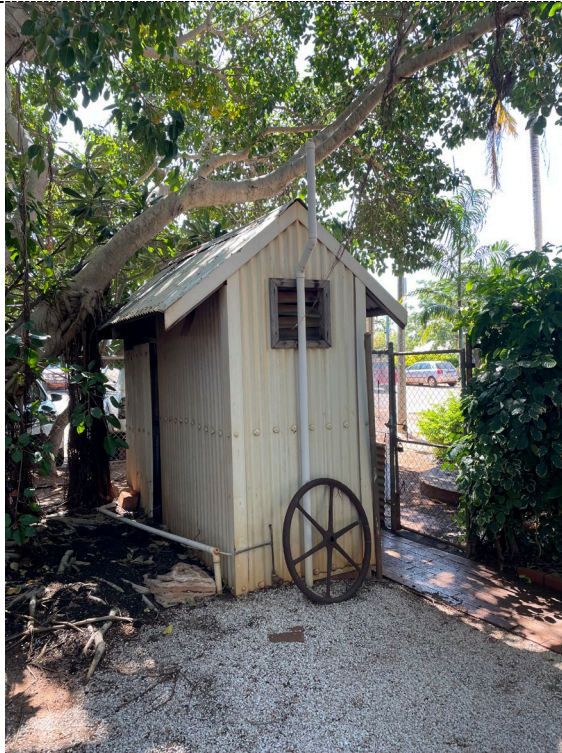
**Figure 29. Old WC / store to the west of Customs House.**

Further north from the ablutions block towards the lot boundary is a very small single gable roofed timber framed corrugated iron clad WC built c. 1970 (as indicated in historic aerial imagery). It is no longer in use and used a store and does not contribute to the significance of the place.

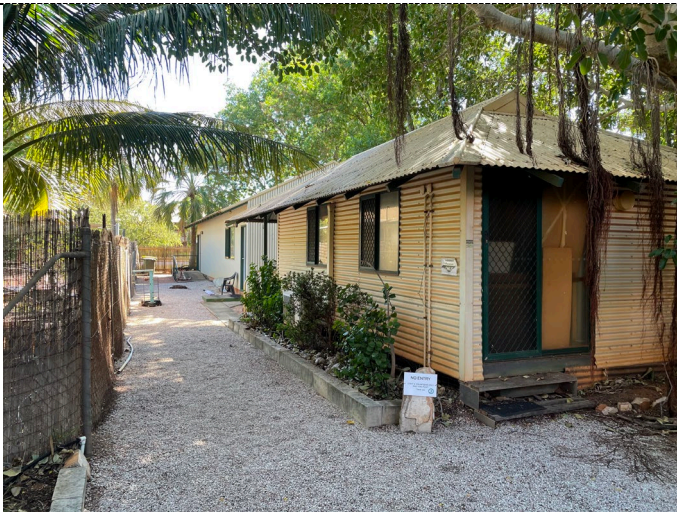
**Figure 30. Administration and archive buildings, to the west of Customs House, constructed between 1970 and 2000, likely c.1980s.**

West of the ablution block and old WC is a free-standing administration building of prefabricated construction with horizontal corrugated steel cladding and hipped roof. It is elevated off the ground with steel stumps. West of this building, in the same alignment, is an archive building of similar prefabricated construction but with a gable roof and resting on a concrete slab.

These two structures are of secondary significance to the place for their association with the Broome Historical Museum.

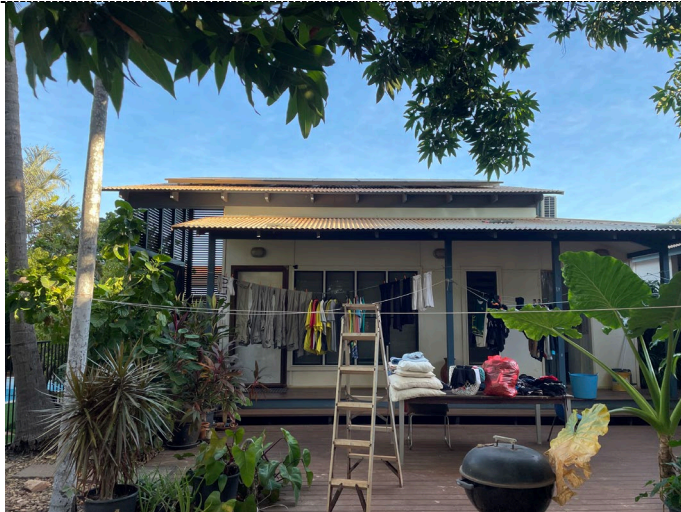
**Figure 31. Building addition directly adjacent to the Sub-Collector's Residence.**

Immediately adjacent to the east of the Sub-Collector's Residence is a single-storey laundry and bedroom addition built c2012. It is a steel framed structure, of contemporary design, clad with white fibre cement sheeting, horizontal timber shading slats, and has a distinguishing raised monopitch roof and separate verandah.

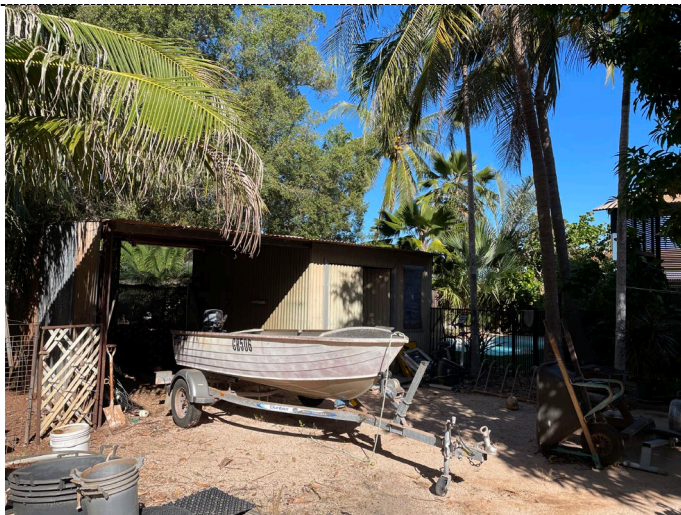
**Figure 32. Half open shed to rear yard of the Sub-Collector's Residence.**

There is a half open shed structure clad with corrugated steel sheeting to the north-east of the house, that was constructed with old railway tracks from the Broome tramway in the 1990s. This is of secondary significance.

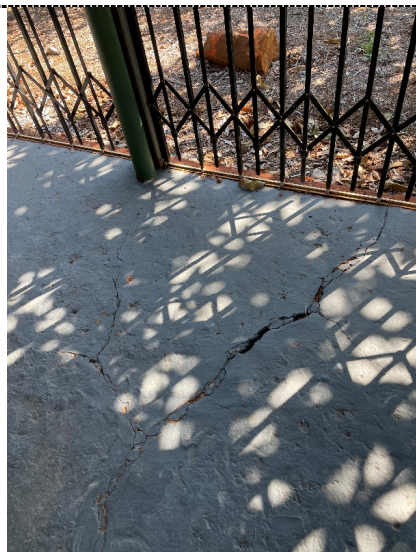
**Figure 34. Customs House - north verandah floor.**

Cracking evident to verandah concrete floor slab.

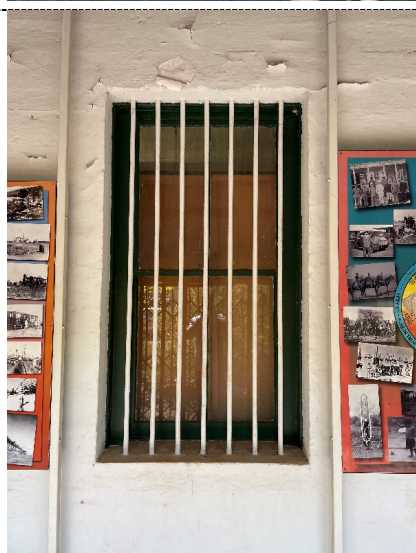
**Figure 35. Customs House - north façade detail.**

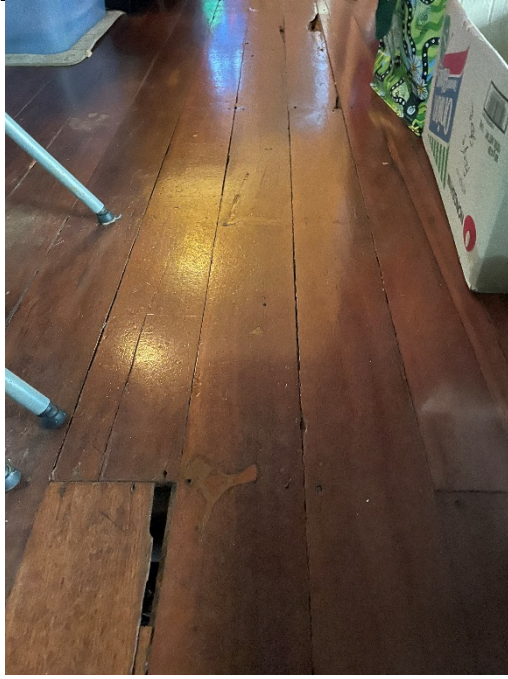
**Figure 36. Sub-Collector's Residence - internal floorboards.**

Jarrah floorboards appear to have suffered from decay and termite damage resulting in significant gaps and gouges.

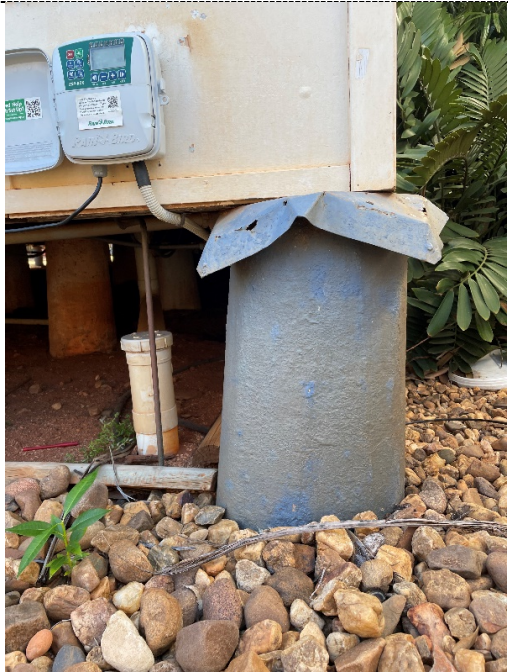
**Figure 37. Sub-Collector's Residence - detail of concrete ground stump.**

There is evidence of rust to the ant caps on top of concrete stumps.

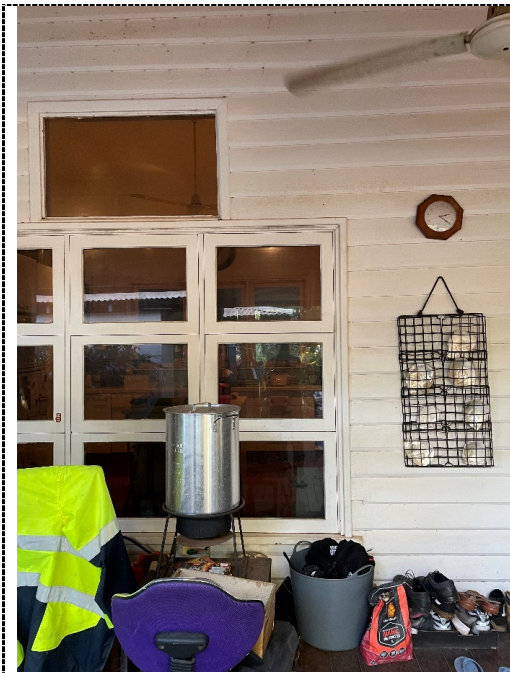
**Figure 38. Sub-Collector's Residence, detail of east façade.**

Instances of black mould growth is evident to the external timber weatherboarding, which is a common problem due to the humid climate.

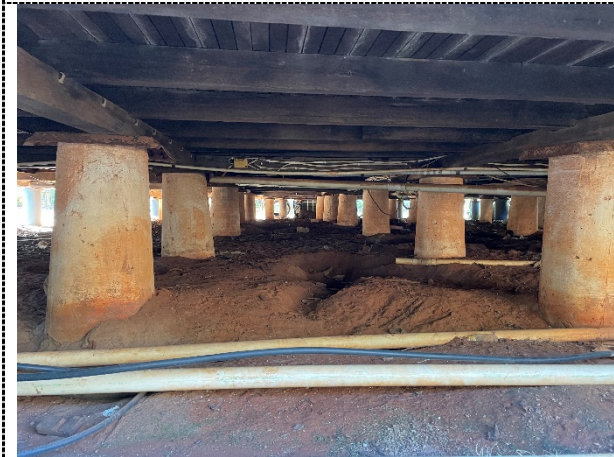
**Figure 39. Sub-Collector's Residence - view of raised ground floor structure.**

The concrete ground stumps have deteriorated and appear to have suffered from subsidence (below ground downward movement), which has affected the rest of the house, in particular the ground floor structure resulting in uneven floors.
