HERITAGE  
COUNCIL  
OF WESTERN AUSTRALIA

## REGISTER OF HERITAGE PLACES Supporting Information

### 10. ASSESSMENT OF CULTURAL HERITAGE SIGNIFICANCE

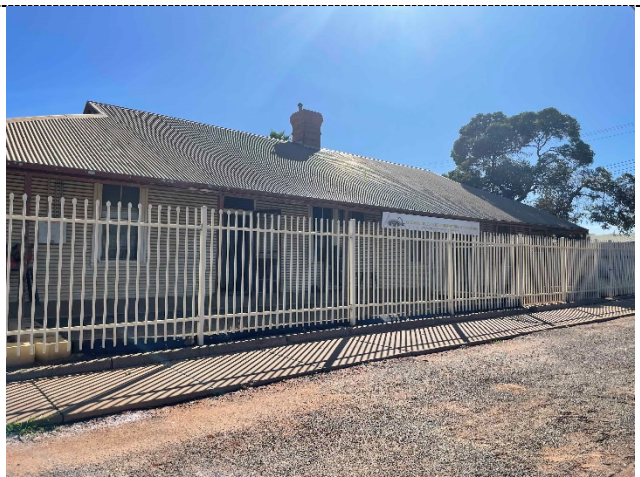
**Figure 7. Exterior view of Police Station & Quarters (fmr) from Piesse Street**

The site is fenced with 1800mm high garrison-style fencing to Piesse Street boundary and 1600mm high corrugated steel fencing on steel posts and rails to the east, west and north boundaries.

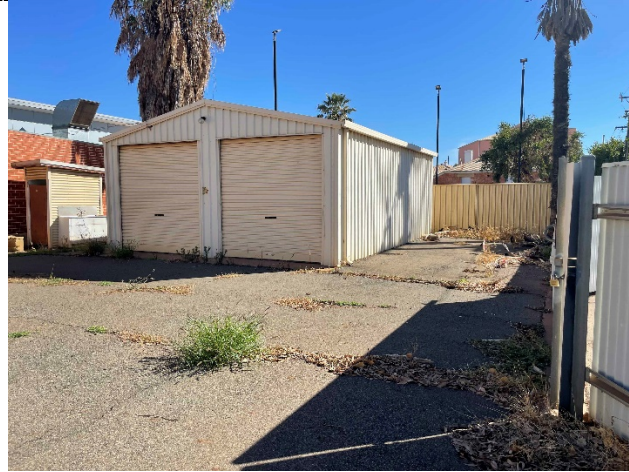
**Figure 8. View of outbuilding in rear yard of Police Station & Quarters (fmr) looking north towards Court House. Note the three matching palm trees.**

The rear yard extends to the northeast of the building and currently accommodates a single-storey steel-framed shed (c.2007) 6m x 8m in size, set within an asphalt hardstand and flanked either side by tall and established palm trees. There is also an established eucalypt tree on the east side of the building.

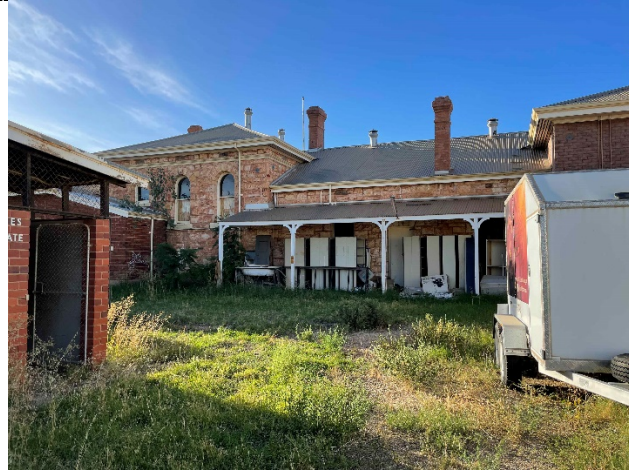
**Figure 11. Rear view of Boulder Court House with nearby ancillary buildings**

The rear yard is generally overgrown with grasses and invasive immature trees that are growing at the base of walls and on horizontal windowsills. Notable features include a prefabricated extension, a shed, and a brick ablutions block, and a mature peppercorn tree.

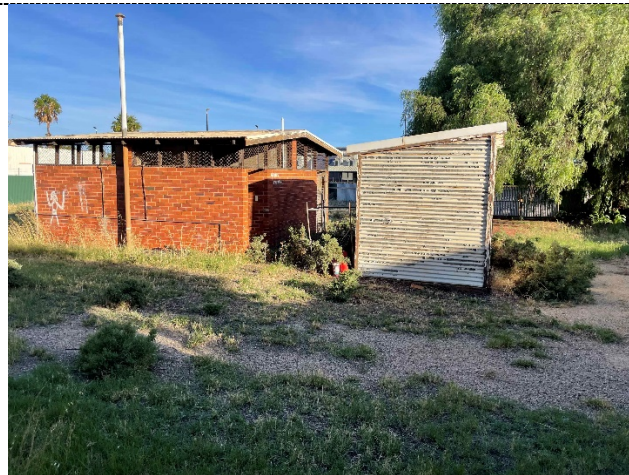
**Figure 12. Outbuildings and mature peppercorn tree in rear yard of Court House lot.**

There are three outbuildings at the rear of the site; a free-standing brick ablution building (c.1961 - pictured); a prefabricated extension attached to the rear of the bank tenancy (post-1963); and a small timber-framed shed clad in corrugated iron (post-1963 - pictured). There is a mature peppercorn tree to the southwest corner of the site.

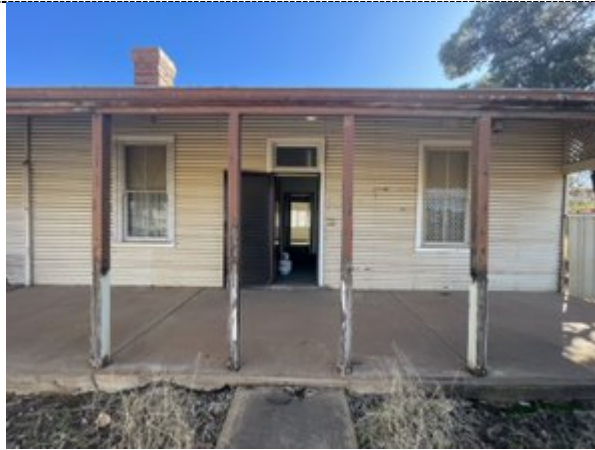
**Figure 14. East tenancy entry and modified posts**

The simple rectangular form, its symmetrical façade, vertically-proportioned windows and lack of artifice are characteristics of the Victorian Georgian style, albeit rendered in timber-frame and corrugated iron instead of traditional masonry. The original timber decking has been replaced with concrete slabs.

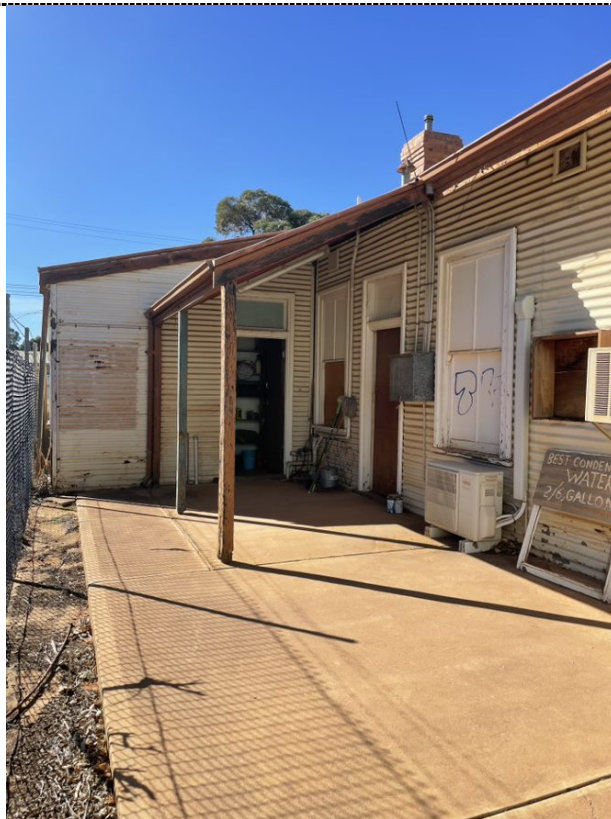
**Figure 15. North elevation verandah of the Police Station.**

The wall cladding shows evidence of previous patching and repair, particularly where external openings have been infilled or windows relocated. The walls also include high level wall vents, some of which have been sealed over.

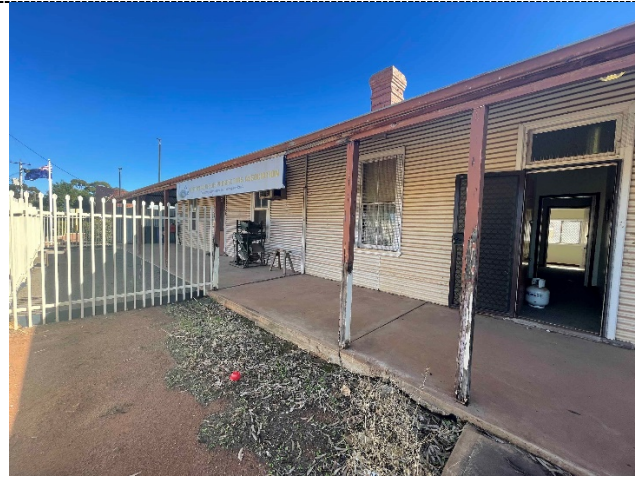
**Figure 16. View of fence diving east and west tenancies of the Police Station**

The verandahs are incorporated under the main roof and extend across the north south and west elevations, comprising square painted timber posts supported on stirrups, that are set into concrete decking.

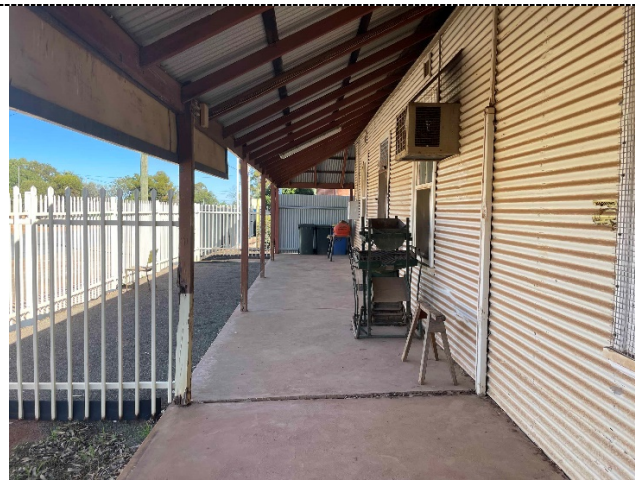
**Figure 17. Police Station and Quarters (fmr) - View looking west along south verandah**

The external walls are clad in short sheets of painted corrugated iron laid horizontally, fixed with flathead nails, with painted timber trims to corners and junctions. The wall cladding shows evidence of previous patching and repair, particularly where external openings have been infilled or windows relocated.

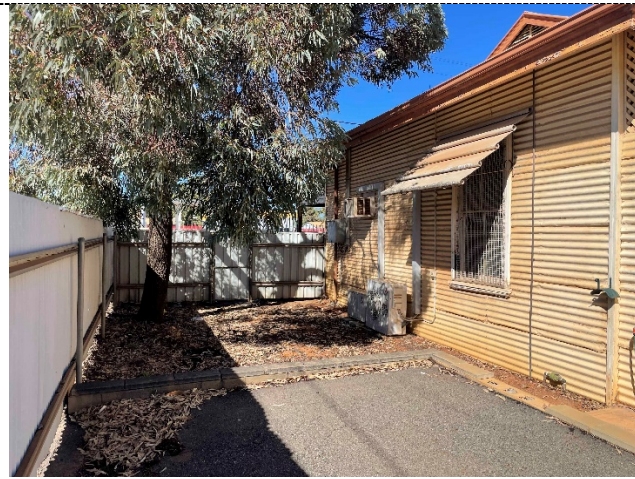
**Figure 18. Police Station and Quarters (fmr) - View of east elevation**

The windows are typically timber-framed multi-pane vertical sash windows in variable condition. Some windows are protected with makeshift security screens (solid plywood, steel mesh, wire mesh) to protect glazing, and these have simple painted timber architraves. The window awning is a modern addition.

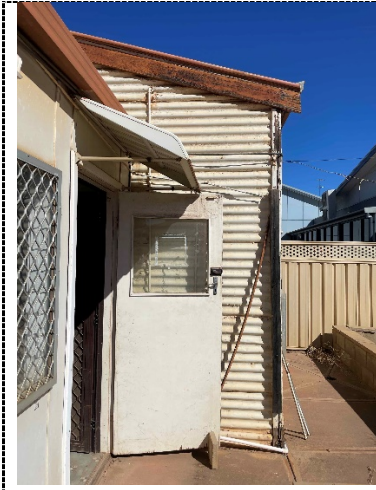
**Figure 19. Police Station and Quarters (fmr) - View of north elevation with partly infilled rear verandahs**

The portion of verandah to the rear (northeast) elevation has been infilled with asbestos sheet and modern aluminium-framed windows to convert this to an interior space.

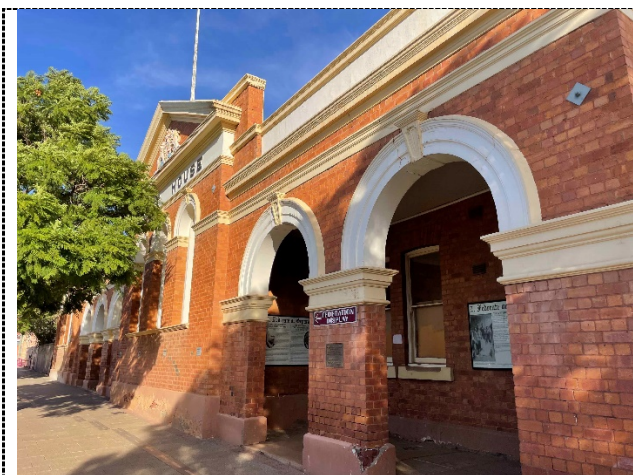
**Figure 20. Court House (fmr) - North elevation of Court House showing central 'Court House' gable flanked on either side by colonnades with classical details. The west portion was constructed for the GWS office.**

The face brick walls on the front façade are in English bond (refaced in 1905), which contrasts against the light-coloured rendered mouldings and details, which is typical of this architectural style. The external colonnade spaces are positioned either side of the central 'Court House' gable and comprise recessed spaces set behind a series of brick arched openings that abut the street.

The roof is hipped, except for the gable features, and is clad in corrugated iron with ogee profile gutters and round steel downpipes. The original brick chimneys contribute to the distinct roof line of the building, which also

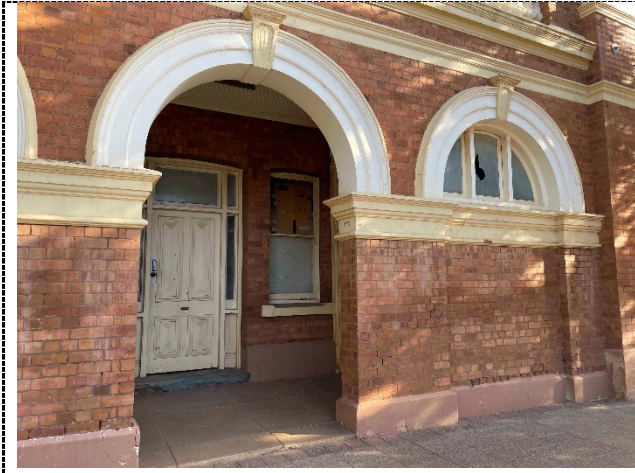
<p>features raised galvanised iron ceiling vents with Chinaman's hat cowls.</p> <p><b>Figure 21. Court House (fmr) - View of eastern colonnade</b></p> <p>The Federation Free Classical style is expressed through ornate mouldings and arched brickwork. Contrasting colours emphasise the details of the facade.</p> <p>The entry door into the Court House comprises a timber-framed four panel door with glazed sidelights and toplight.</p> <p>The original timber joinery is evident throughout the buildings, including all the fenestrations, such as the double-hung windows arranged in threes to the front gables, as well as those setback in the colonnade.</p>
 	<p><b>Figure 22. Court House (fmr) - View of west elevation adjoining Infant Health Centre</b></p> <p>The building is set back from the west boundary, allowing vertically-proportioned windows and a recessed arch reveal to become features of the side elevation.</p>

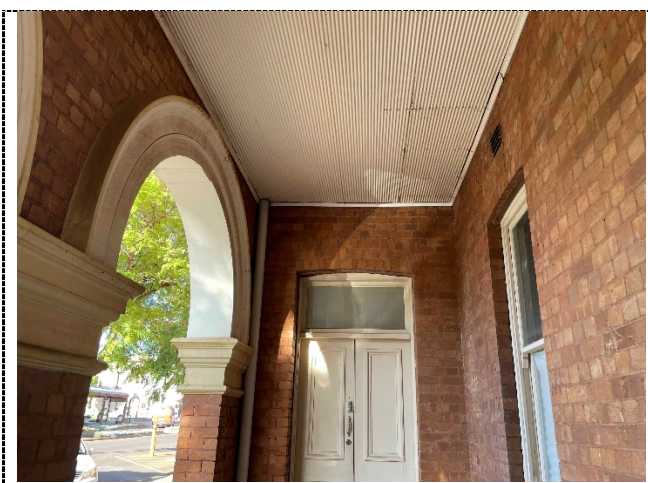
**Figure 24. Court House (fmr) - Interior view of east colonnade showing typical finishes**

The external colonnade spaces are positioned either side of the central 'Court House' gable and comprise recessed spaces set behind a series of brick arched openings that abut the street. The interior of each recess has face brick masonry walls, concrete deck floors (with a timber access ramp to the westernmost colonnade) and mini-orb lined ceilings.

The external doors providing access into the former Bank building and the Goldfields Water Supply office both comprise a pair of timber panelled doors with fanlight above.

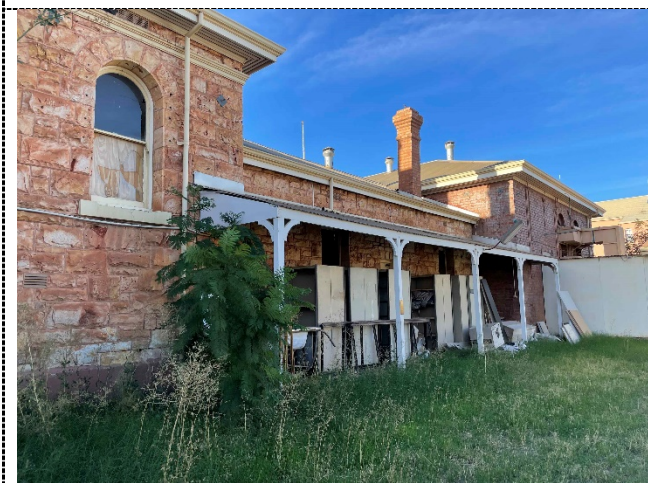
**Figure 25. Court House (fmr) - Exterior view of rear (south) elevation**

The original random ashlar stone walls that once characterised the building are still evident on the south elevation.

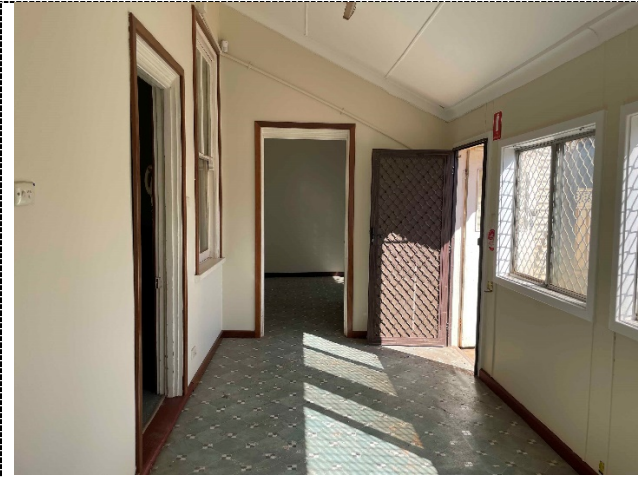
**Figure 26. Police Station and Quarters (fmr) - Interior view of enclosed verandah in east tenancy**

The original verandahs have been enclosed with stud walls clad in plasterboard and the original timber decking has been replaced with concrete slabs.

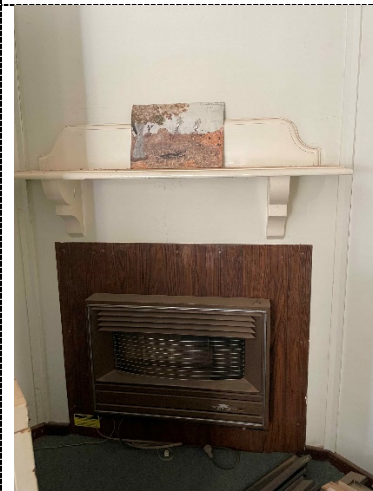
**Figure 27. Police Station and Quarters (fmr) - Interior view of fireplace in living room of east tenancy**

The original fireplace mantles and surrounds have been boarded up in some instances with retrofitted gas heaters installed (pictured).

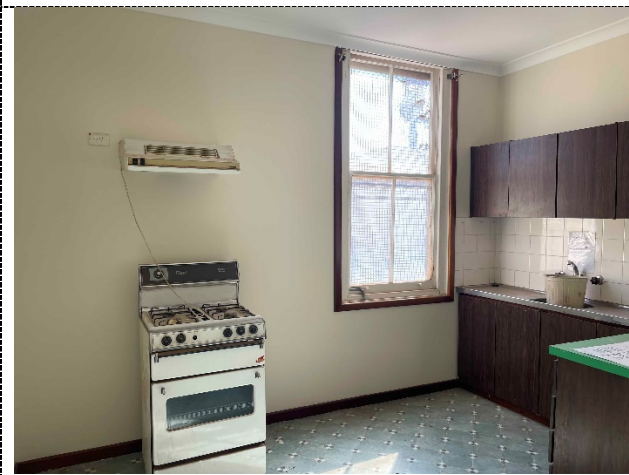
**Figure 28. Police Station and Quarters (fmr) - Interior view of kitchen in east tenancy**

The easternmost tenancy retains its original internal layout of rooms, but the internal finishes are lower authenticity comprising mostly modern plasterboard linings to walls and ceilings, with standard coved skirtings and varnished timber skirtings and architraves. The kitchen fit-out likely dates from the c.1970s/80s and is of little significance.

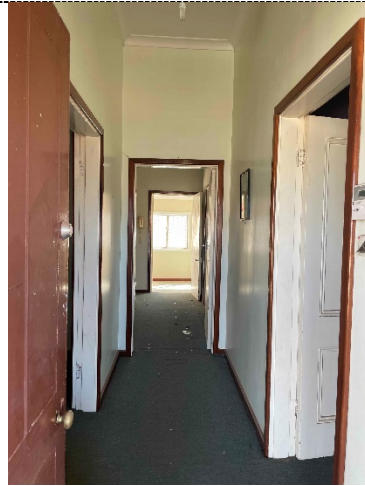
**Figure 29. Police Station and Quarters (fmr) - View of passage looking north in east tenancy**

Each tenancy comprises a central passageway running north-south and flanked on either side by four rooms and providing access through to the north verandahs and Kitchen.

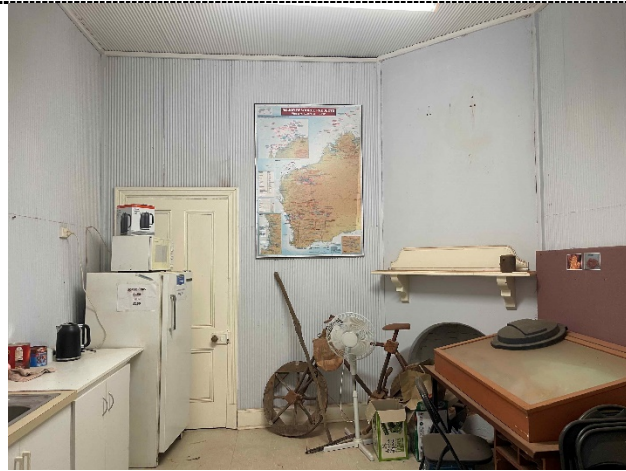
**Figure 31. Police Station and Quarters (fmr) - View of Living Room looking east in west tenancy**

Mini-orb wall and ceiling linings, and ornate painted timber trims and skirtings are among the original fabric that remain intact in the western tenancy. The current kitchen fit-out is likely salvaged from another location and is c.1980s

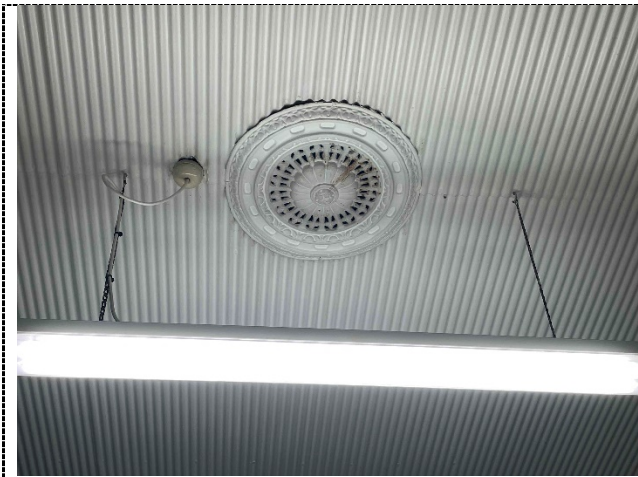
**Figure 32. Police Station and Quarters (fmr) - Detail view of ceiling in Living Room in west tenancy**

Original fabric remains, including mini-orb ceiling linings and ornate pressed metal ceiling vents

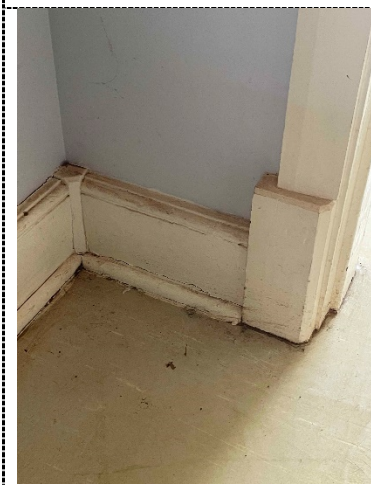
**Figure 33. Police Station and Quarters (fmr) - original joinery**

Ornate timber joinery, including door frames and skirtings are an original feature that has been retained. The original timber floorboards also remain and are covered by carpet and vinyl.

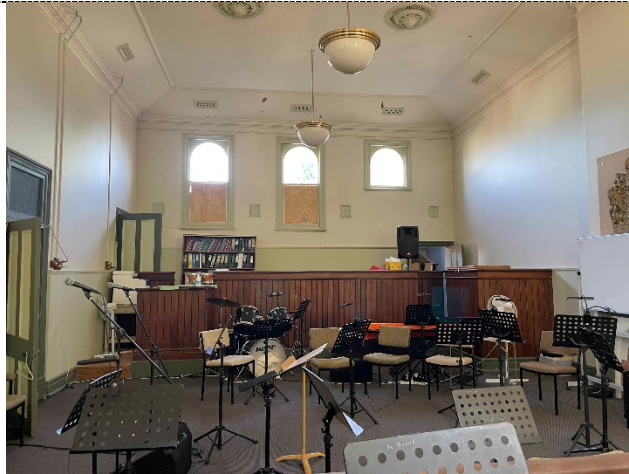
**Figure 34. Court House (fmr) - Court Room looking towards bench**

The Court Room is an impressive generous-volume space with the Judges Bench and Dock retained at its southern end, and the public gallery at its northern end. The room retains considerable original fabric throughout including rendered and painted walls with horizontal dado scribing, plaster ceilings with decorative vented ceiling roses, ornate skirtings and cornices as well as the timber joinery bench, dock and public gallery railing. The space is currently used as a music practice area.

Note the original timber faced windows, some of which have been clad over with protective plywood to address ongoing vandalism.

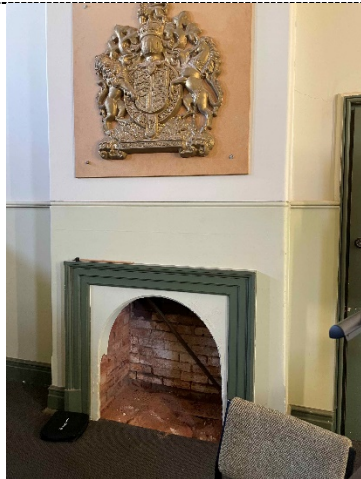
**Figure 35. Court House (fmr) - Detail view of Court Room fireplace**

The brick fireplace in the Court Room retains its arched opening and timber surround.

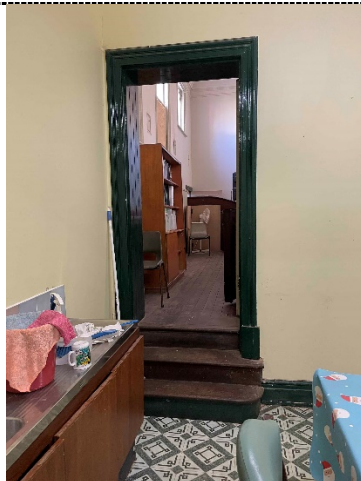
**Figure 36. Court House (fmr) - View Magistrates Room west door through to Bench**

Other significant fabric includes the original timber-framed windows and panelled doors, and timber joinery. The existing kitchen fitout is c.1970s, as is the vinyl flooring

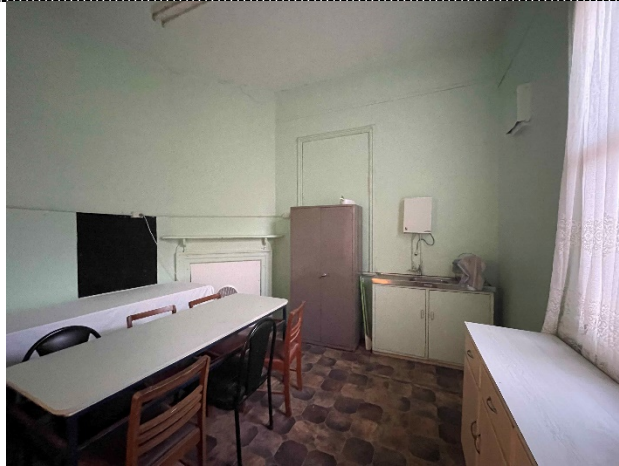
**Figure 37. Former GWS Office - View of Engineers Office**

The former GWS office is located behind the main public office and retains original wall finishes. The floors are modern vinyl laid over timber and the fireplaces and some openings have been closed over. The existing fit-out is c1970s.

The offices have flush jointed ceilings with ornate vented ceiling roses, plain rendered walls and ornate timber skirtings and mantelpieces. All rooms retain their original timber-framed four panelled doors with toplights.

One of the windows in the Engineers Office has been sealed over with ply and the fireplace has also been sealed in this room.

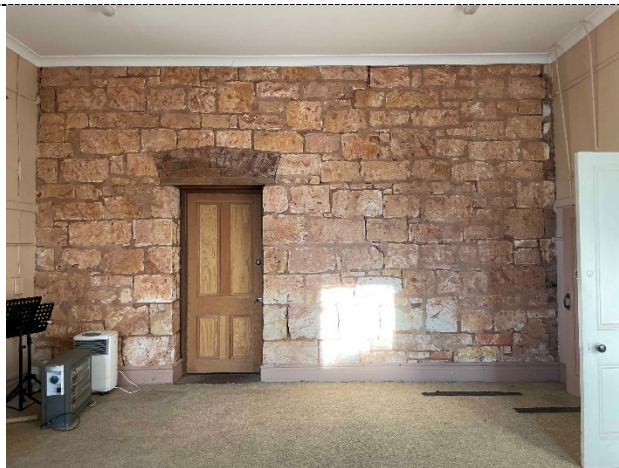
**Figure 38. Former GWS Office - east wall, shared with Court House**

The east wall is random ashlar stonework that represents the original façade of the 1900 Court House. The original timber floors are retained under carpet floor coverings.

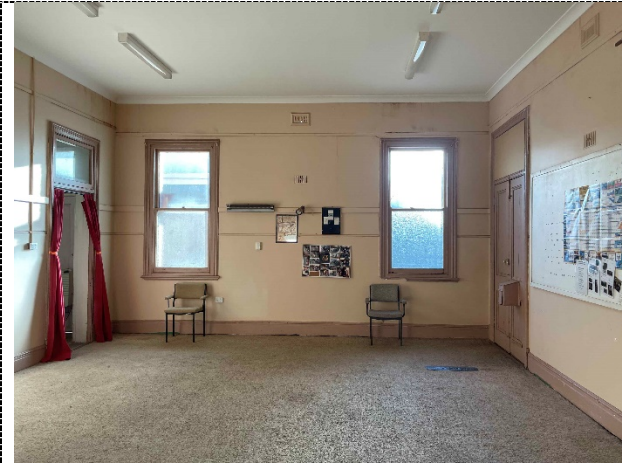
**Figure 39. Former GWS Office - west wall towards entry door**

Vertically-proportioned, timber-framed sash windows are located to the north and west walls, which are rendered and painted with scribed horizontal dados and timber picture rails above. The room retains its original timber joinery, but the ceiling and coved cornice are more contemporary replacements.

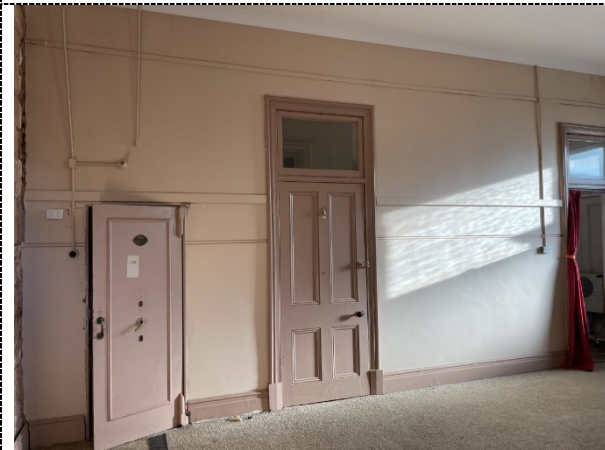
**Figure 40. Former GWS Office - Safe and Door**

There is a masonry safe accessible from the SE corner of the room, which retains its original strong door.

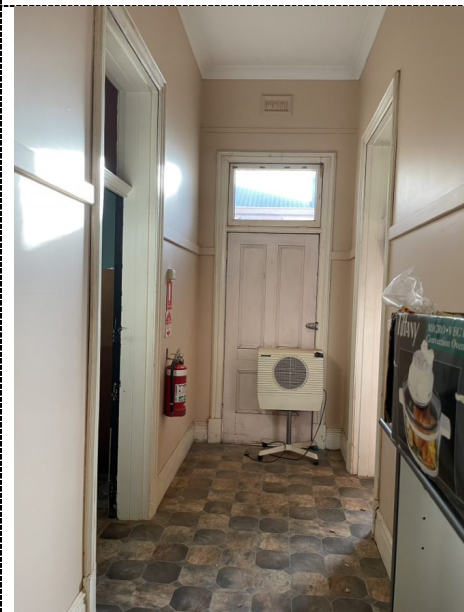
**Figure 41 Former GWS Office - passageway**

The offices to the rear of the building are accessed by a central passageway that has an external door at its western end. The passageway has vinyl floor coverings and rendered and painted walls with timber dados, timber skirtings and architraves to doors and windows. To the left is the former Engineers Office.

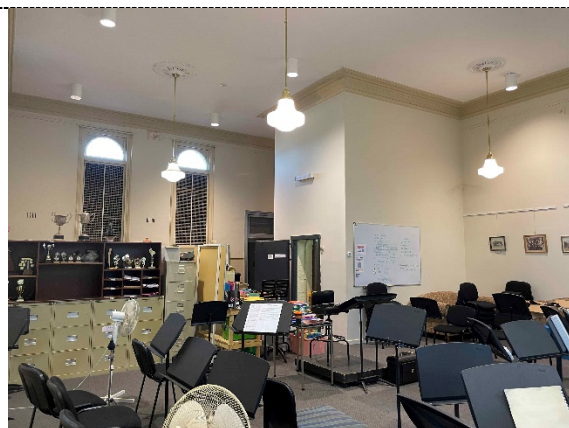
**Figure 42. Savings Bank – view looking south west towards Strong Room**

The internal walls are rendered and painted with a scribed dado at 1600mm high and ornate cornices and wall vents retained throughout, along with the plaster ceilings with decorative vented ceiling roses. The timber floors are carpeted throughout.

Elsewhere the room retains its original timber sash windows and panelled doors

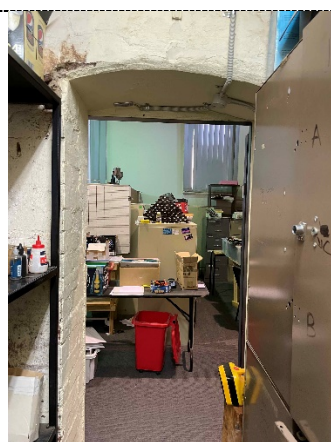
**Figure 43. Savings Bank - Interior view of Strong Room**

The Strong Room is the only remaining evidence of the original fitout of the Savings Bank. The original heavy-duty strong room door is intact, with a Chubb safe installed within.

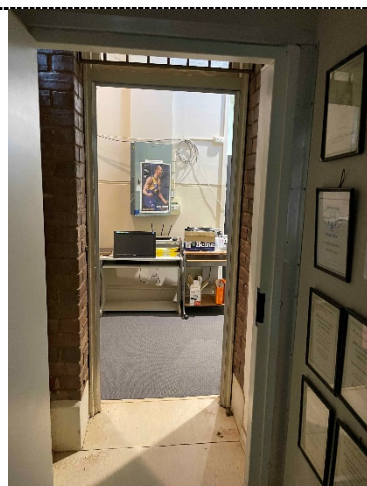
**Figure 44. Savings Bank - View from prefabricated building (post-1963) into Savings Bank south wall**

The external door on the south wall provides access through to the transportable building installed to the rear of the Court House, which is of little significance.

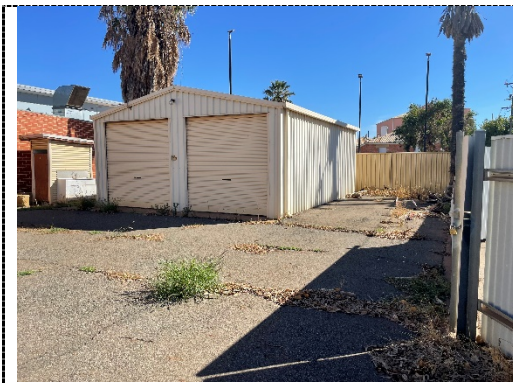
**Figure 45. Police Station and Quarters (fmr) - View of outbuildings in rear yard looking north towards Court House. Note the palm tree.**

There is a modern steel-framed shed (c.2007) located to the rear of the former Police Station & Quarters, which is not original fabric.

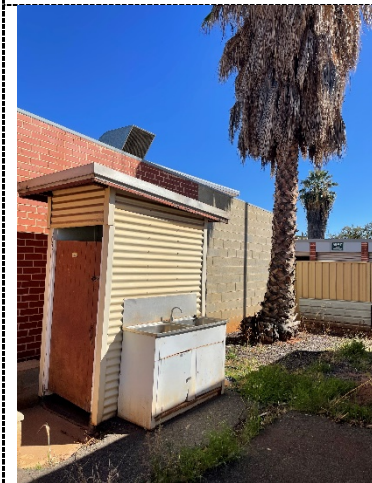
**Figure 46. Police Station & Quarters (fmr) - View of ablution block in rear yard looking north towards Court House. Note the two matching palm trees.**

There were once an array of outbuildings associated with the former Police Station & Quarters including Holding Cells & Exercise yard, Wash house, Earth closets and Stables.

This outbuilding was constructed c.2007 and is not original fabric.

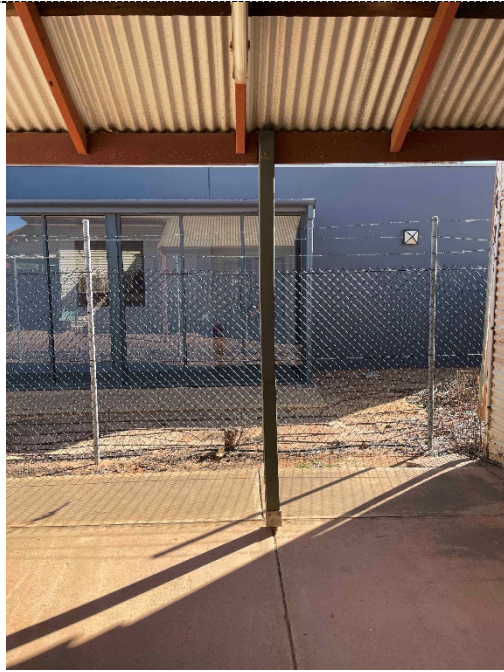
**Figure 47. Police Station and Quarters (fmr) - The proximity of the adjoining Main Roads development as viewed from the north verandah**

This adjacent site is where the location of the former holding cells were located, which were demolished sometime after 1963. The original Police Station lot has been substantially redeveloped since the place was first constructed, and the adjoining MRWA building is located in close proximity on the north and west sides of the original building. A chainmesh fence divides the sites.

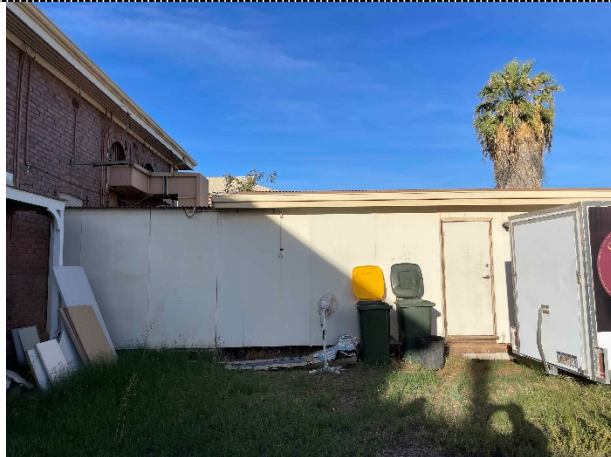
**Figure 48. Court House (fmr) - Transportable building attached to rear of the Savings Bank. Note the palm tree.**

It is likely this extension was constructed after 1963 and before 1992, as indicated by historical aerial imagery and the 1992 Conservation Plan. This transportable building is not original fabric.

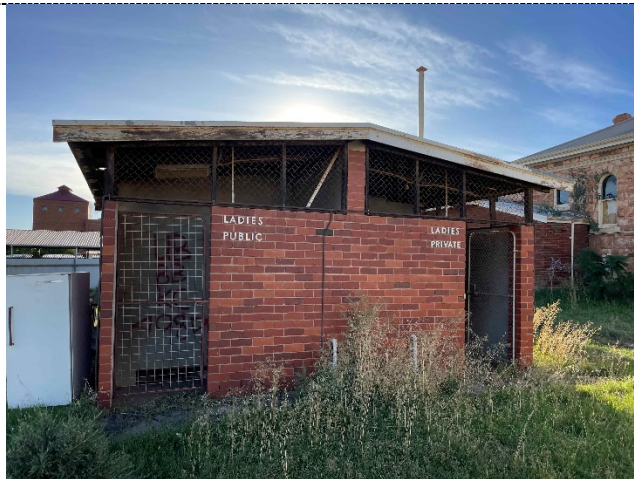
**Figure 49. Court House - Brick ablutions in rear yard (c. 1961)**

This brick ablutions block is one of three outbuildings to the rear of the Court House. Others include a modern transportable building attached to the rear of the Savings Bank and a timber-framed shed clad with corrugated iron (both post-1963).

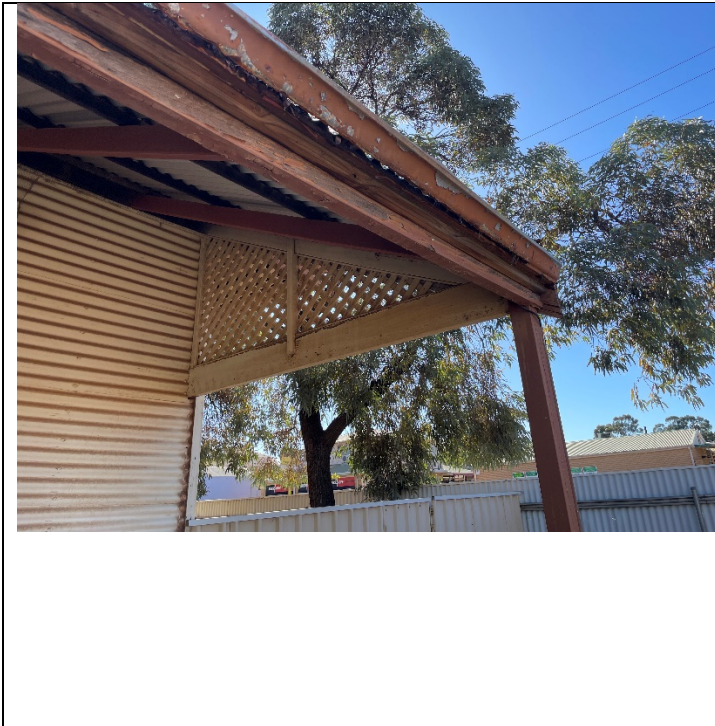
**Figure 50. Police Station and Quarters (fmr) – Verandah and Roof**

The external timber verandah posts are in variable condition, many requiring localised repair where cracked or rotted at their base. Deterioration of the timber joinery to the verandah posts as well as the fenestrations is evident, with damage caused by weather exposure and lack of protective paint coatings.

The roof appears in sound condition, but the gutters and downpipes are corroded or missing in some sections.

An example of both is the corroded rainwater goods and timber joinery to the south elevation

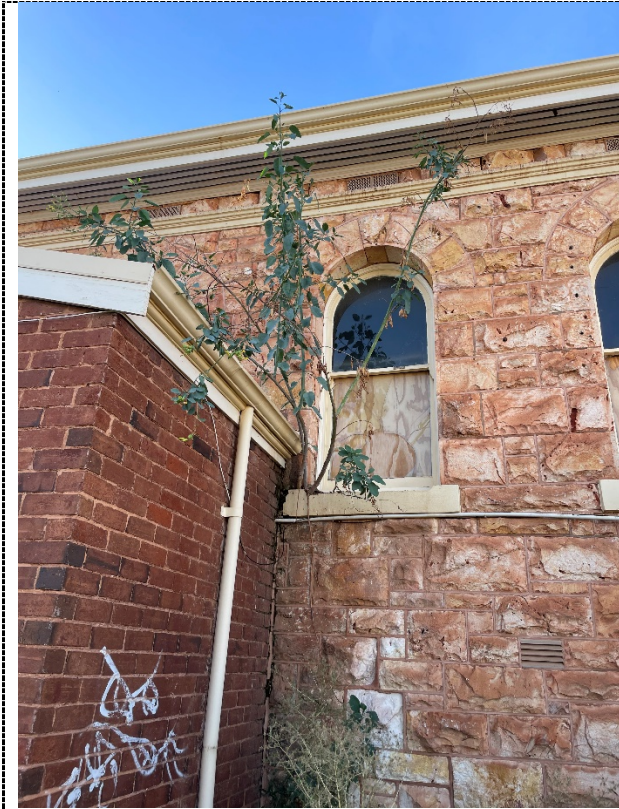
**Figure 51. Court House (fmr) – Rear Elevation**

Some invasive weeds growing from the masonry sill are causing damage to the significant fabric.

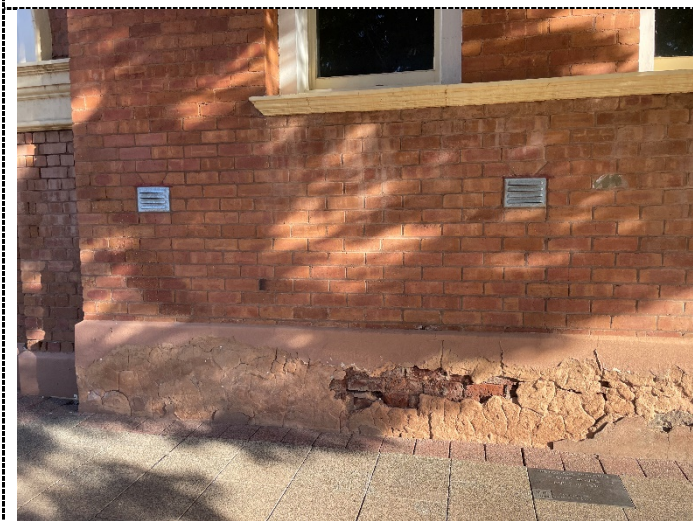
**Figure 52. Court House (fmr) – Front Façade**

In some cases, render to the lower plinth wall has broken away entirely from the brick substrate.

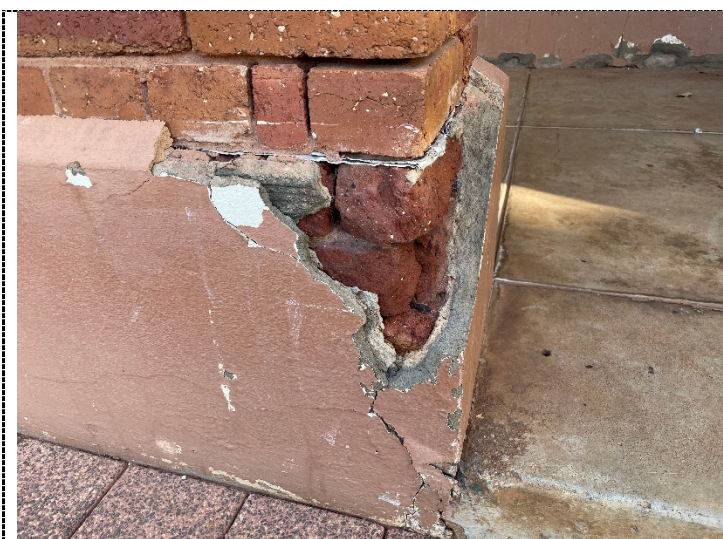
Boulder Court House (fmr) is in fair-good condition. The building has some significant rising damp issues throughout, with fretting and damage to external render and face brickwork evident, as well as damage to internal plaster finishes and timber joinery affected by damp.

<p><b>Figure 53. Court House (fmr) – North Elevation Plinth</b></p> <p>The building has some significant rising damp issues throughout, with fretting and damage to external render and face brickwork evident. Note the fretted brickwork and the exposed damp proof course to the lower brick wall.</p>

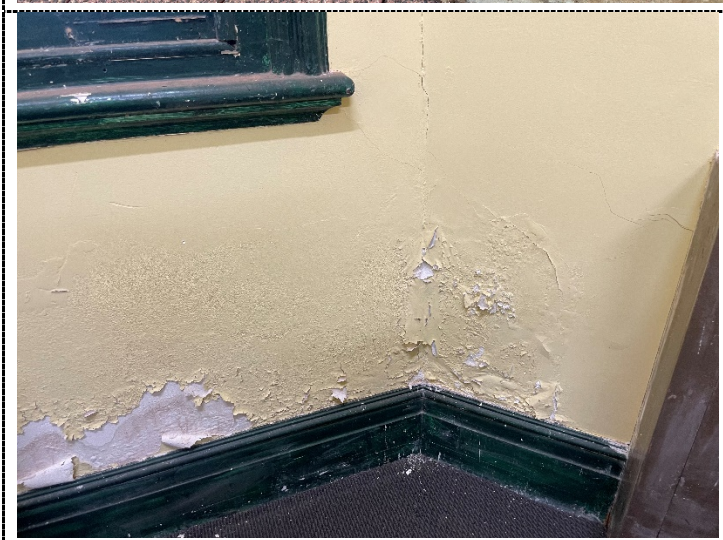
<p><b>Figure 54. Court House (fmr) – Witness Room Interior</b></p> <p>The Court House building has some significant rising damp issues to the interior, including to plaster finishes and timber joinery.</p>

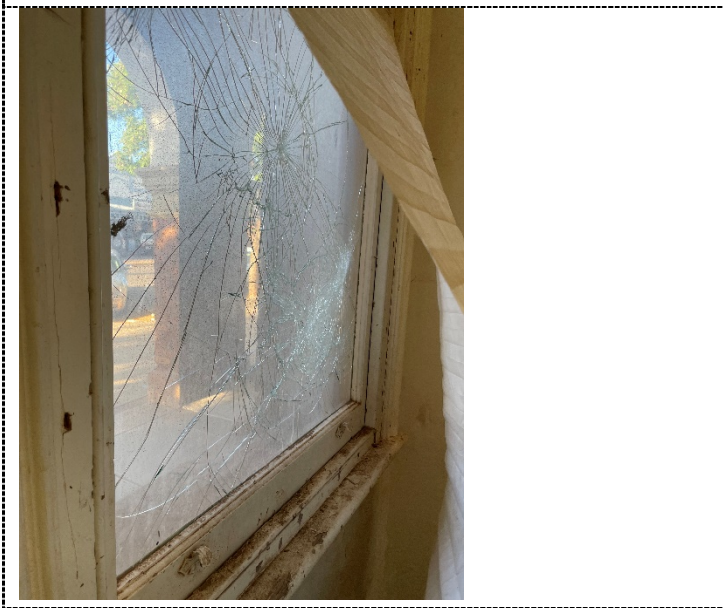
<p><b>Figure 55. Court House (fmr) – Witness Room.</b></p> <p>Some windows and doors have been broken from vandalism and are now sealed up with infill material. An example is the damage to this original timber-framed window in the Witness Room.</p>
