REGISTER OF HERITAGE PLACES

Assessment Documentation

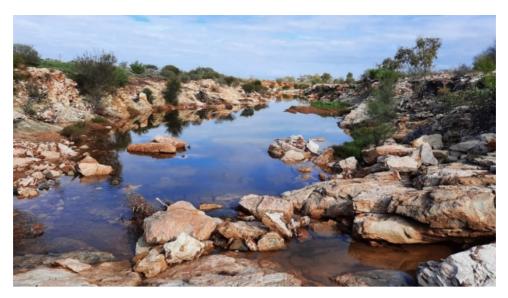
Well 2 (Woodenooka Government Well)

Built in July 1895, the Woodenooka Government well lies near the Woodenooka Spring and creek bed. The square well is 2.2 metres wide and 12 metres deep. It provided an average supply of 150 gallons (682 litres) per hour of brackish water. The original stonework, which lined the well, is still visible in some areas. The well is in an average to poor condition.

Water has risen to the top of the well where it is lined with stone around the opening. Timber planks and metal pipes likely once relating to the function of the well that are scattered around. Likely due to the unsafe nature of the well, given its high water level, it is surrounded by wire fencing. Grasses, large shrubs and small trees surround the well, due to the presence of water. Access to Woodenooka Government Well is down a gravel track east of the Carnarvon-Mullewa Road.

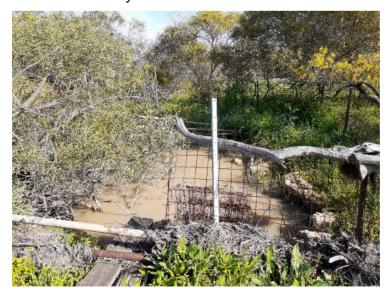
Bedan Well

This well is not listed as a government well, so it is likely it was privately sunk. Shrub and low-lying vegetation cover the opening of the well making it hard to see the stone that lines it. Four metal pickets indicate each side. Access to the well is along Bedan Road, which leads west from Carnarvon – Mullewa Road.

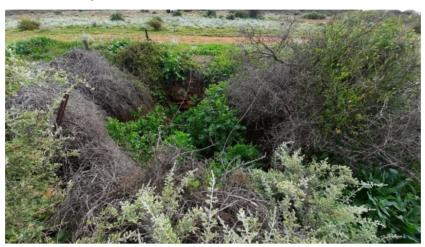
Well 3 is stone lined for the first 3 feet, and then is natural earth for the remaining depth. The round well is roughly one metre in diameter. Its water level was 12 feet from ground level in 1982, during Sharp's visit. The water trough leading from the well is in poor condition, having rusted at the base and is broken in other parts. A wire fence surrounds the well to keep livestock from falling in. Various grasses and low shrubs surround the well.

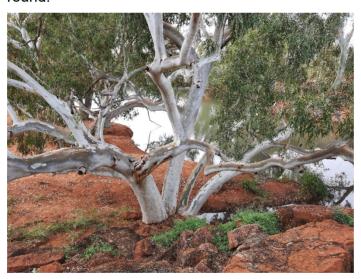
As noted in Sharp 1985 account, Well 20A 'is about 2 miles north of Belang Pool. [The walls of the well] are lined with Mulga poles.' 101 At this time in 1982, a mill was set over the well but was no longer in use. During the 2021 site visit all that remained of the mill was portions of metal sheeting, likely the mill tail, and a metal pole used in the framework.

Rusted metal batwing covers partially cover the opening. They are no longer fixed to the timber and are slightly out of place. A Mulga pole extends over the opening of the well and a metal pipe is attached to it leading to the water. The remains of what may have been a gin pole or windlass lie close to the opening of the well, having deteriorated significantly from insect activity. Stone and cement that has broken apart lead away from the well, possibly once acting as a trough. A tire is also located at the well as well as portions of metal sheeting and a metal pole.

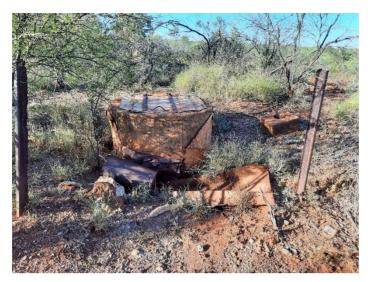
In 2021 the well had not changed significantly. A metal bucket and other metal scrap was found next to the well.

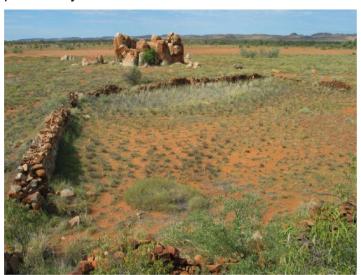
The construction of stock-yards from stone is characteristic of several nearby sites. These are rectangular in design and thus resemble those at Springs and Chirrita stations. The use of stone at the other sites suggest these were used for holding densely packed stock during shearing. However, there is no evidence of shearing at this site and these structures may have been used to pen sheep at night during the early colonial period, to keep the stock from wandering off and safe from predators.' 140

The stone yards appear to be an example of dry stone wall construction, which is particularly rare in Western Australia.

Stone yards, Shire of Roebourne (now City of Karratha) Local Government Heritage Inventory. 141

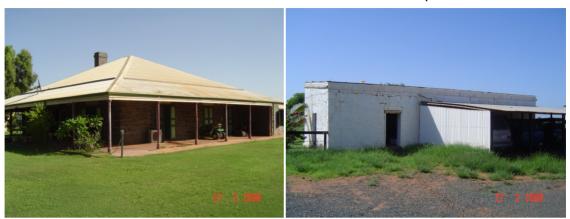
The single-storey homestead is comprised of bluestone and concrete and has an expansive single pitched roof and a surrounding verandah supported by cast iron posts.

Mundabullangana Homestead and Old Post Office & Store, taken by Department staff 2008.

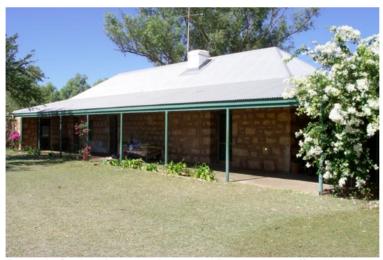
The homestead is comprised of stone and has a corrugated iron roof. A verandah surrounds the exterior.

Boodarie Station Homestead, taken by Department staff 2008.
