HERITAGE AGREEMENT

ROYAL GEORGE HOTEL

(HCWA Place No. 794)

Royal George Hotel 34 Duke Street East Fremantle

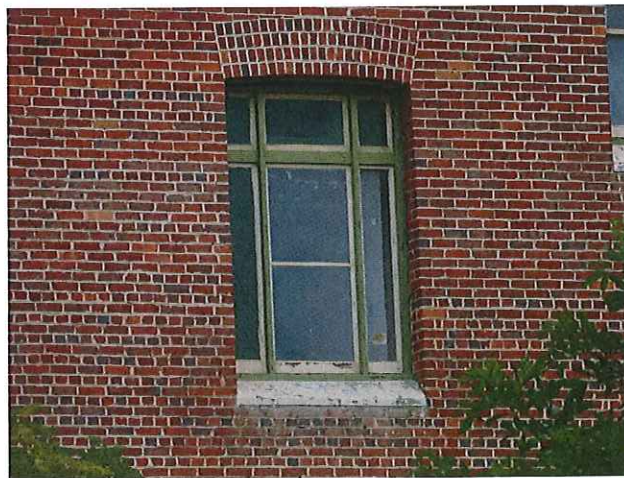
Fig 8. View of window to stair landing - north elevation (TPG)

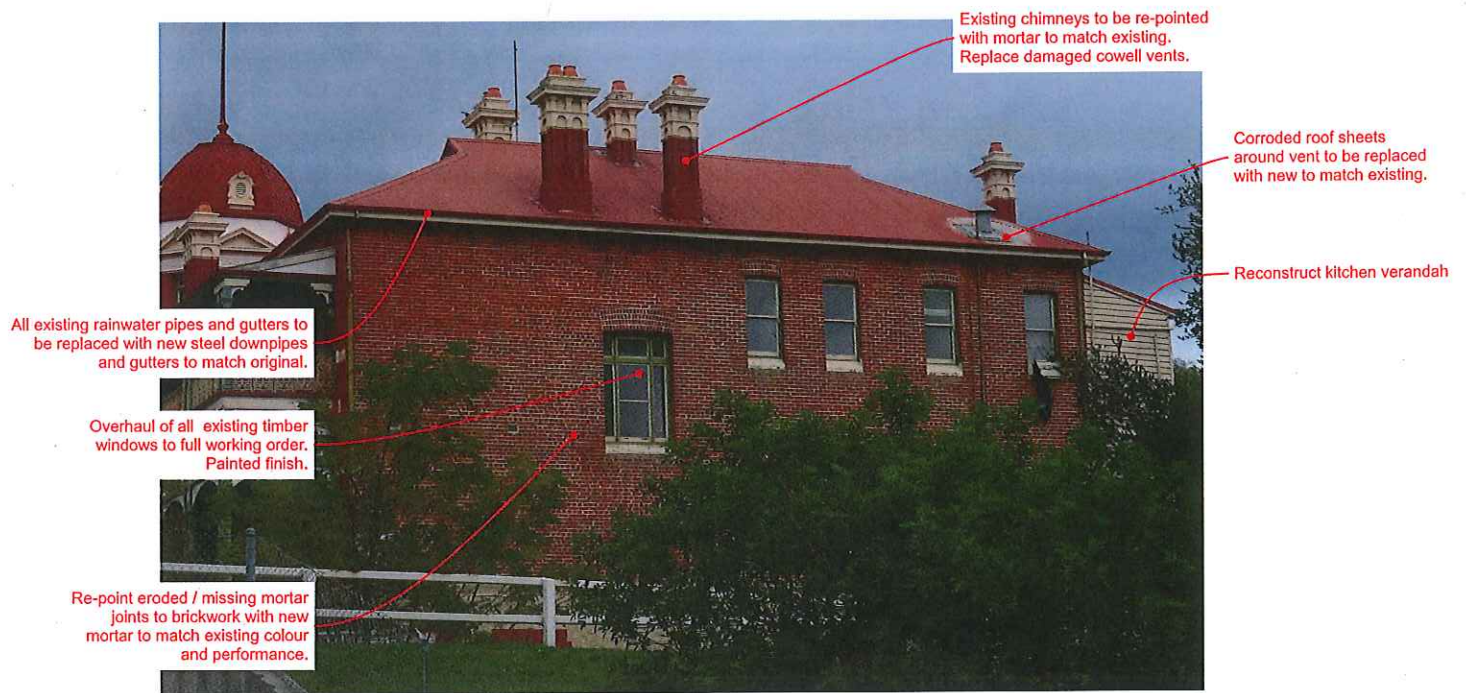
Fig 9. View of East Elevation (TPG)

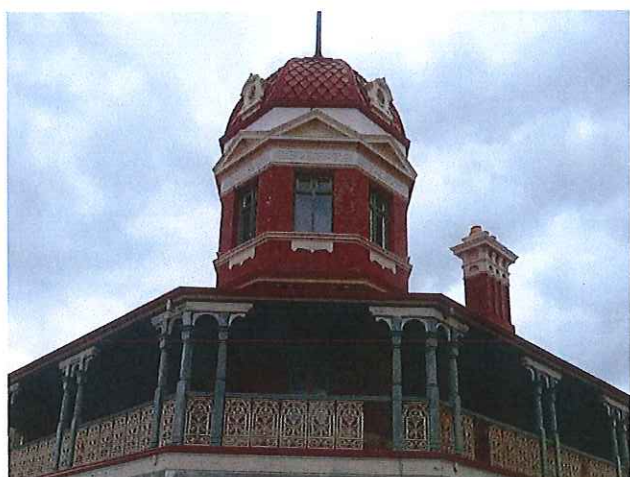
Fig 11. Corner view of cupola (TPG)

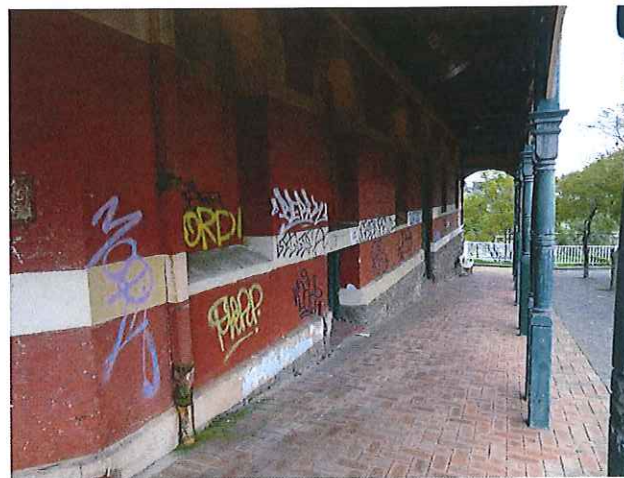
Fig 13. View from along George Street - south elevation (TPG)

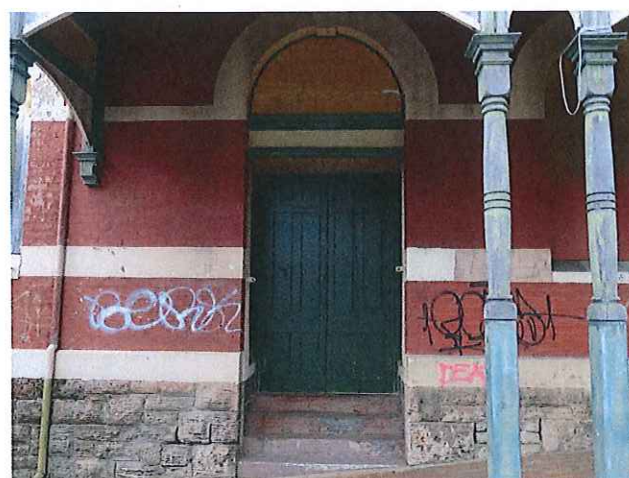
Fig 18. Main entry door off Duke Street - west elevation (TPG)

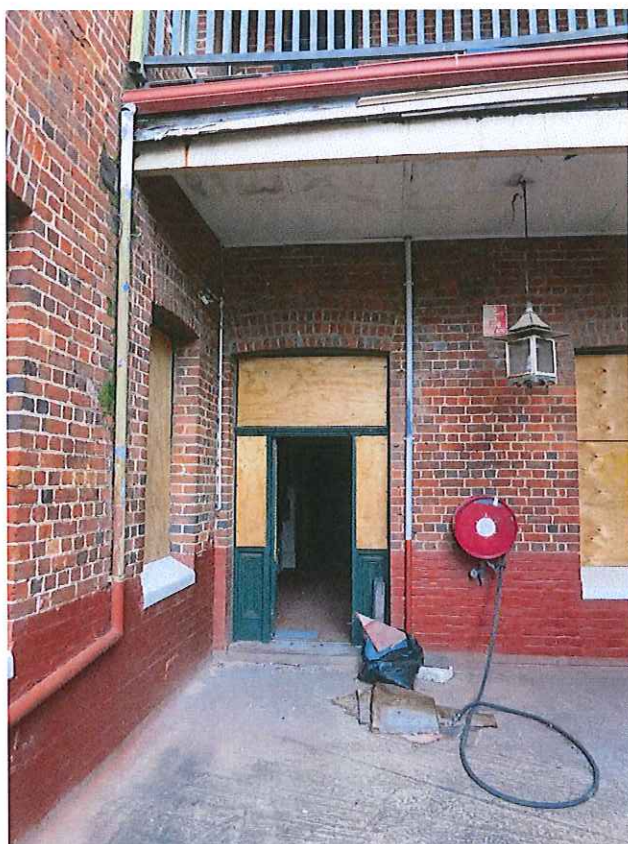
Element	Condition Rating	Comment on Condition	Remediation Works	Extent	Priority Rating
Brickwork	C	Some redundant service conduits. Brickwork painted up to sill height. Mortar eroded / missing in parts. Cement rich mortar in parts. Generally in fair condition.	Remove redundant service conduits. Remove paint. Re-point eroded / missing mortar with new to match existing colour and performance. Rake out all cement rich mortar and re-point to match existing.	100%	2
Timber windows and doors	D	See General Exterior table		10 No.	2
Central Verandah	C	Timber verandah is unsafe and requires thorough inspection	Reconstruct verandah using as much original material as possible. Structural engineers specification for reconstruction is required. Verandah roof cladding to be replaced with CGI bull-nose to match original. All guttering and downpipes to be replaced and painting	100%	2

Fig 23. View of courtyard elevation (TPG)

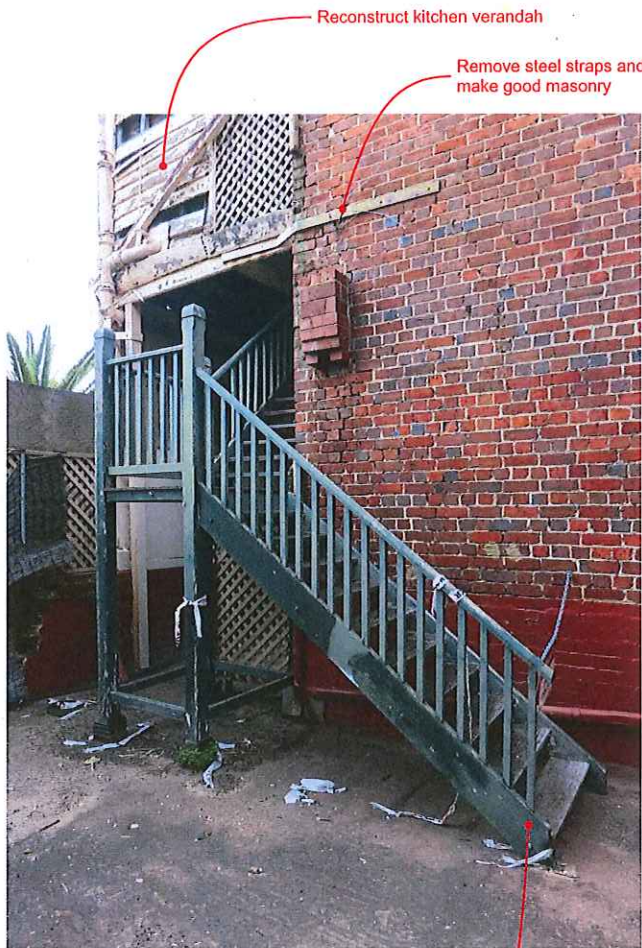
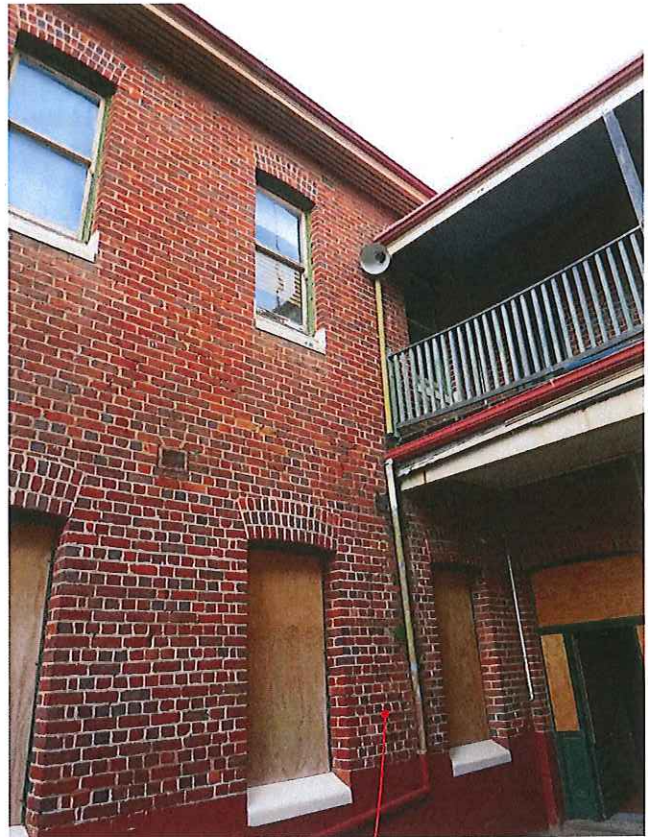
Timber weatherboard	C/D	Weatherboards associated with kitchen verandah are displaced and unfixed.	Allow for reconstruction as part of Kitchen verandah overhaul	100%	2
Lattice partitions	D	Lattice partitions are showing signs of weathering and have become displaced	Reconstruct lattice partitions where required and repaint	100%	3

Fig 26. View of Courtyard Elevation - east (TPG)

Fig 27. View of Courtyard Elevation - east (TPG)

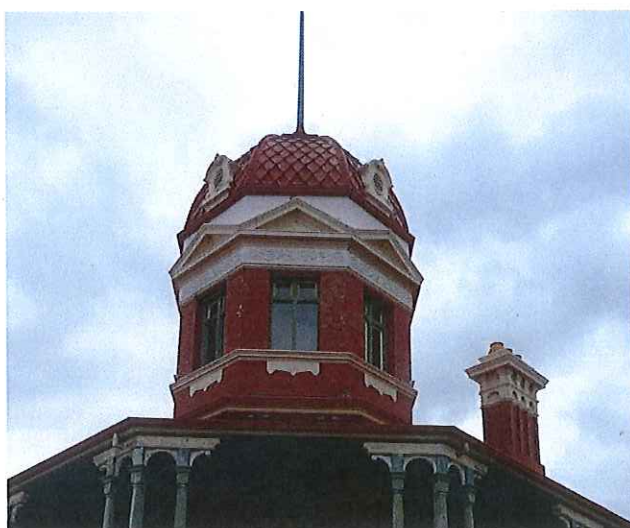
Element	Condition Rating	Comment on Condition	Remediation Works	Extent	Priority Rating
Masonry	C/D	See General Exterior table		100%	2
Verandah	C/D	See General Exterior table		100%	2
Main Corner Entrance	C	Stair leading double leaf timber doors are missing paint. Fan light is covered with boarding	Remove board covering fanlight. Restore entrance including remove flaking paint and repaint. Paint concrete stairs.	100%	2
Tower/ Cupola	C	The fish scale shingles are showing some slippage and lifting that causes water ingress. Gutters are also not functional. Flashings around the tower may also be defective The masonry pediments are displaying some cracks Paint onto brickwork is blistering	Repair fish scale shingles. Use as much of original fabric as possible only replace shingles where they functionally cannot be repaired. Replace stepped flashing where tower penetrates roof sheeting Repair or replace steel ties, lintels and ring beams in accordance with structural engineer specifications. Repair cracks to render and mouldings where required. Remove paint from all face brick	100%	1

Fig 29. View of south west corner of Cupola (TPG)

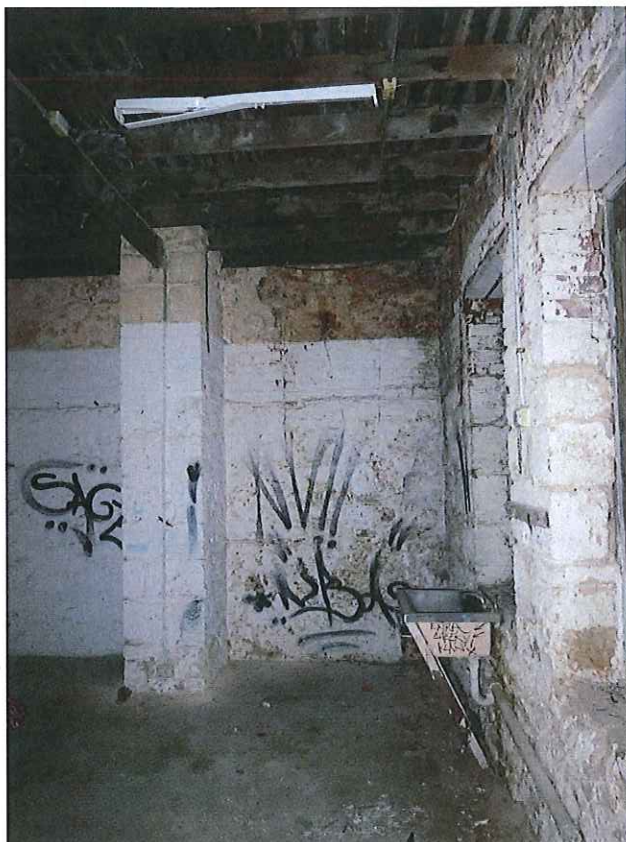
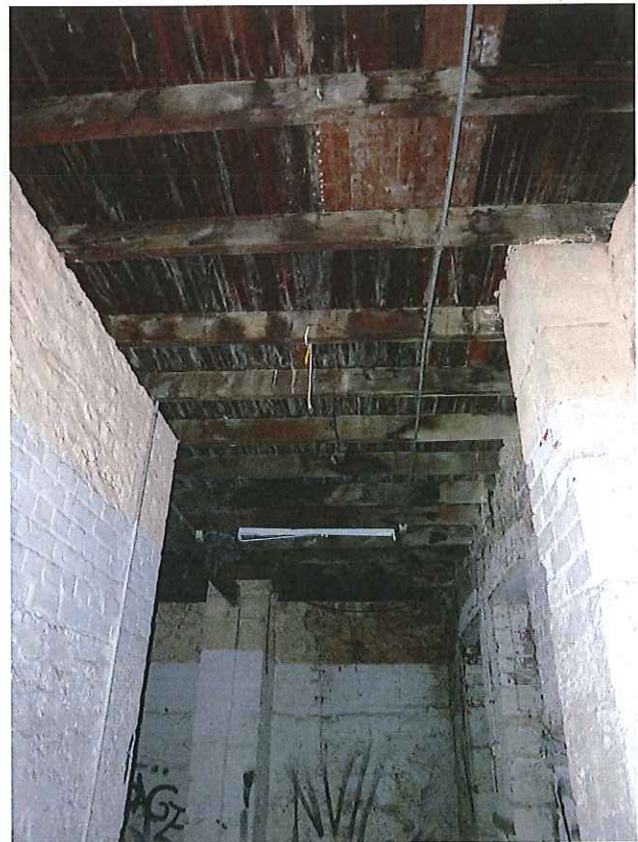
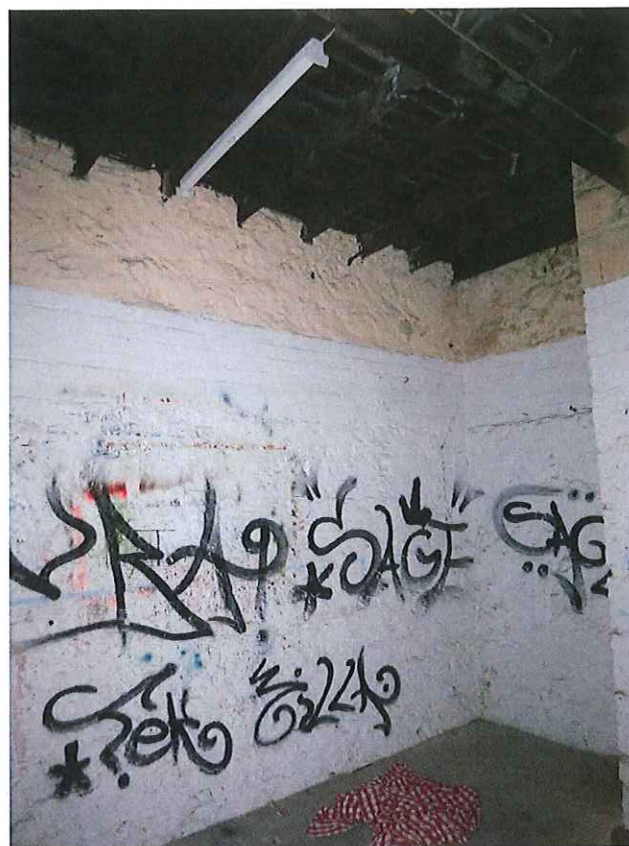
Element	Condition Rating	Comment on Condition	Remediation Works	Extent	Priority Rating
Walls	B	Restricted access.	Repair water damaged bricks and limestone walls. Replace masonry units where required and re-point.	40%	2
Concrete Floors	B	Restricted access.	Replace cracked / broken concrete floors	TBC	3
Access	D	N/A	Provide ladder and trapdoor security to cellar and also to void. Provide stair access to room B4.	Item	3
Room B5 - Ceiling	C	Restricted access.	Reconstruct in-situ suspended concrete slab formed on corrugated iron vault (Tragerwellblech construction).	Item	3
Electrical	N/A	N/A	Remove all redundant cabling and fittings and provide adequate power and lighting to all usable spaces.	Item	3

Fig 37. Room B2 (TPG)

Fig 38. Room B2 (TPG)

Fig 41. Room B2 (TPG)

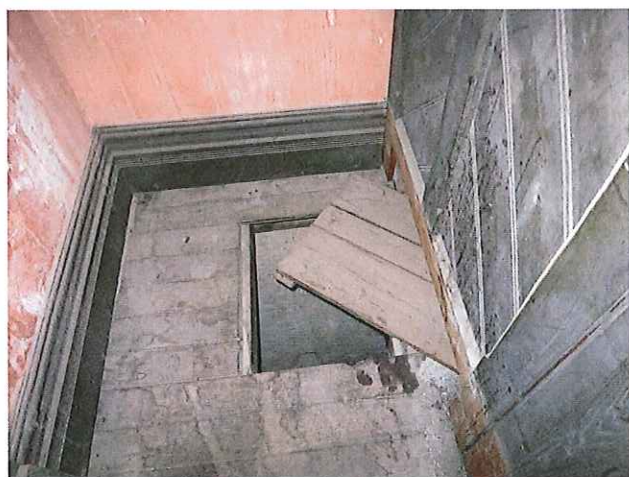
Fig 42. Floor hatch to room 2 (TPG)

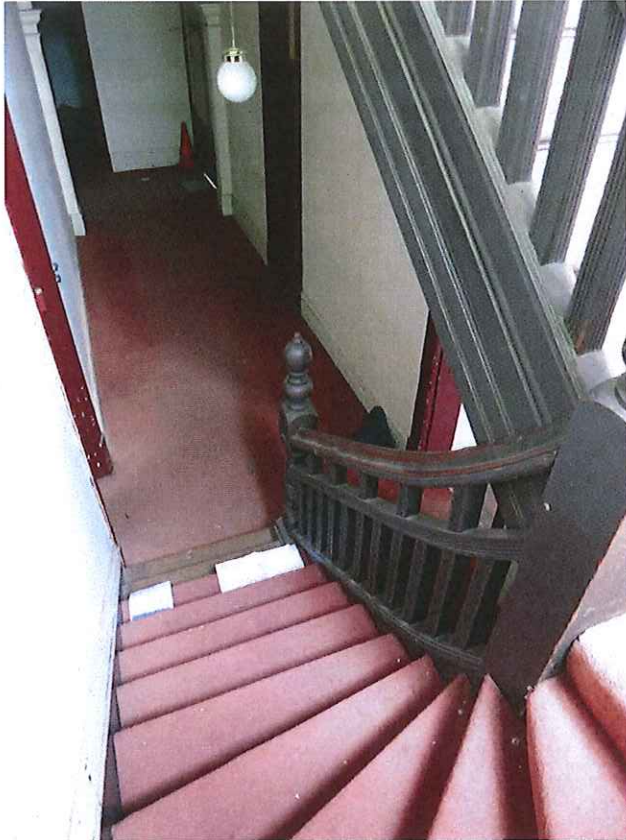
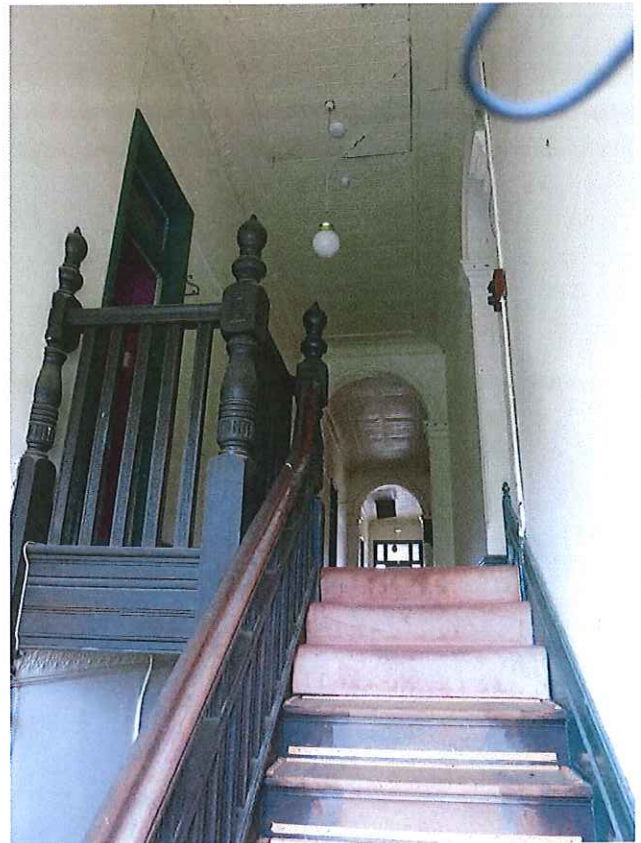
Element	Condition Rating	Comment on Condition	Remediation Works	Extent	Priority Rating
Room R1 - Infilled fireplace	N / A	Existing fireplace to be reinstated if required.	Reinstate fireplace with new surround.	All	4
Hall - Timber staircase (see figs 1 & 2)	B	Generally in good condition	Conserve and retain exposed timberwork to staircase. To be treated with wood stain / varnish (not to be painted). Verify height of existing handrail for BCA compliance. Install new handrail if required. Remove carpet finish to treads.	All	3
Room R4 - Water damaged plaster	D	Peeling paint and drummy plaster due to water damage / rising damp.	Investigate source of water ingress / damp and rectify. Replace damaged plaster with new and make good. Painted finish.	40%	2
Room R5 - Timber window cill and plaster	D	Weather damaged timber cill and wall plaster beneath (see fig. 12)	Investigate source of water ingress and rectify. Replace timber window cill with new to match existing. Remove damaged plaster and make good. Painted finish.	Item	2

Fig 46. Hall - Timber staircase (TPG)

Fig 47. Hall - Timber staircase (TPG)

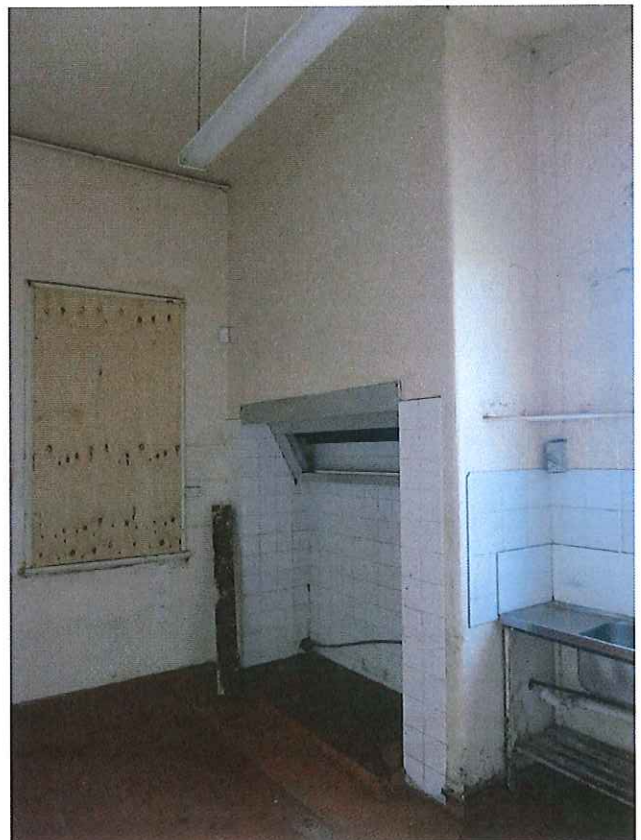
Room R6	C	Generally in fair to poor condition.	Remove fixtures and fittings. Make good wall finishes. Remove floor finish. Parts of door frame to be replaced with new to match existing.	All	3
Room R7 - Kitchen	C	Generally in fair to poor condition.	Remove wall tiles, pipework and redundant fixtures and fittings. Make good floor and wall finishes.	All	3
Room R8 - Ceiling	C/D	Collapsed ceiling.	Cut away damaged ceiling and replace with new plasterboard and make good. Any defective ceiling joists to be replaced. Painted finish.	Item	2
Female WCs	E	No access but visibly in poor condition and is considered intrusive to the original fabric.	To be removed and original fabric to be made good to match existing.	Item	3

Fig 49. Room R7 - Kitchen (TPG)
