**HERITAGE AGREEMENT**

**GUILDFORD HOTEL**  
(HCWA Place No. 2463)

## Conservation Management Strategy

NOVEMBER 2014

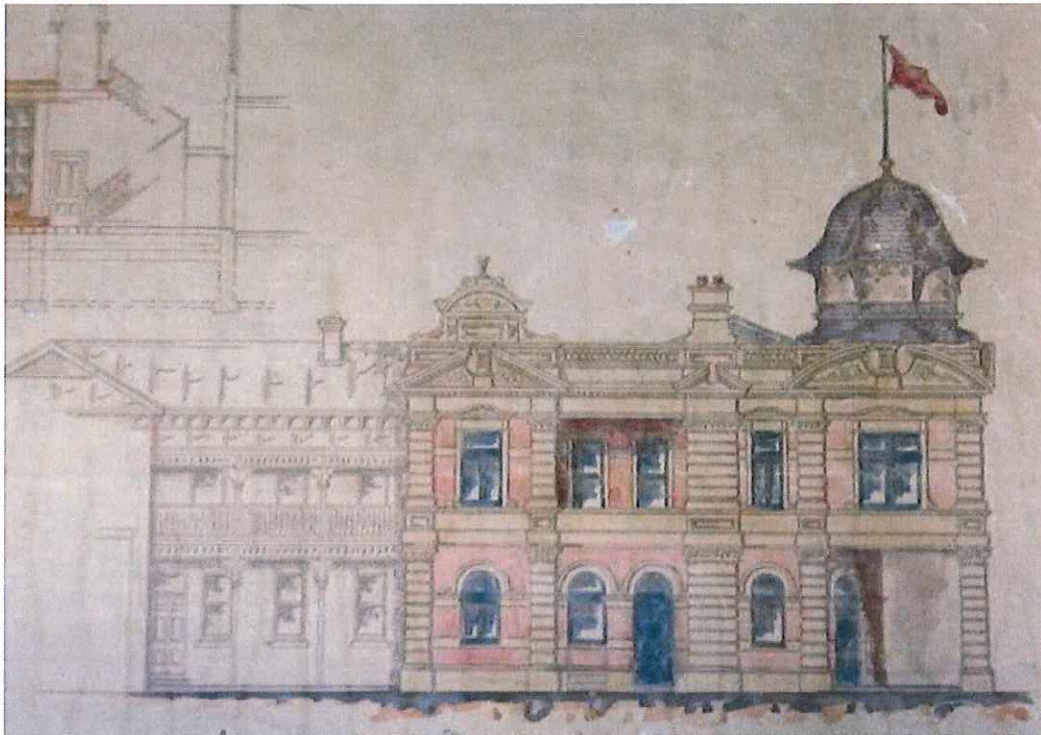
Fig 6. Elevations showing new façade to the Guildford Hotel – Johnson Street elevation c.1914 Source- State Library of Western Australia

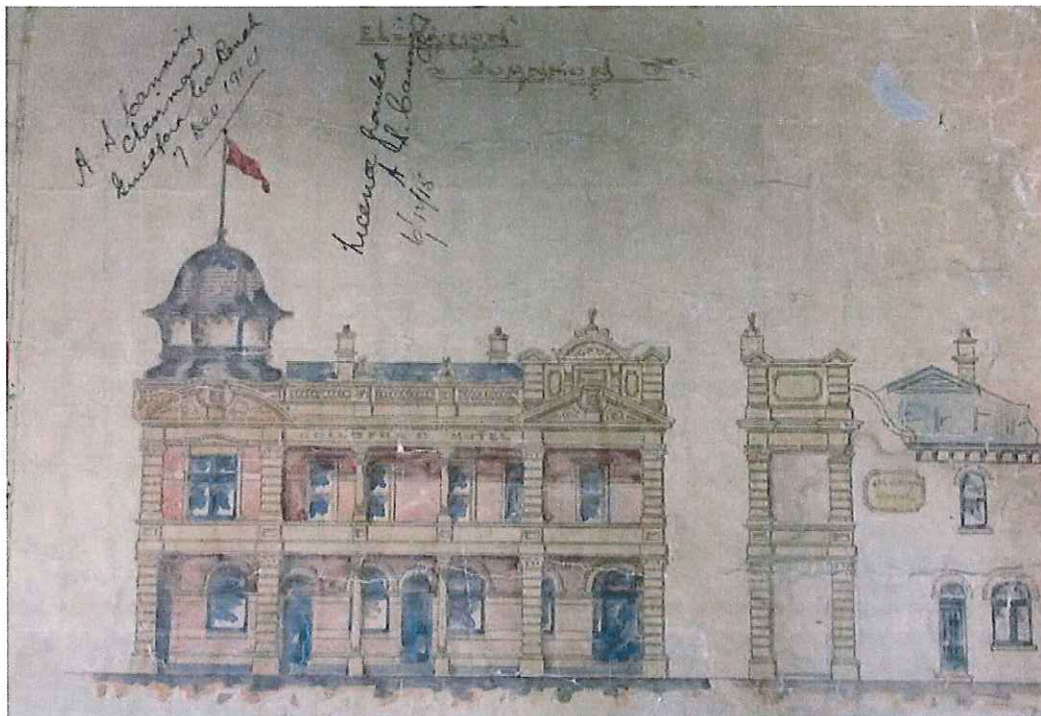
Fig 7. Elevations showing new façade to the Guildford Hotel – James Street elevation c.1914 Source- State Library of Western Australia

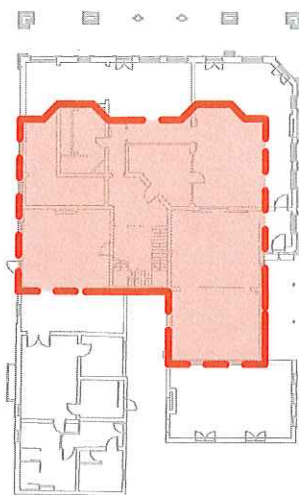
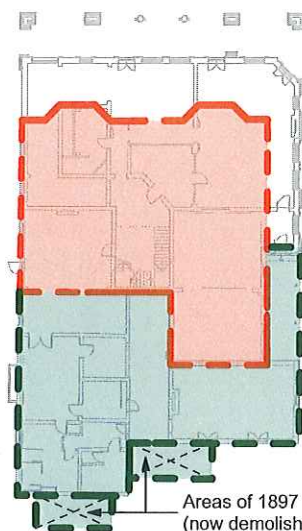
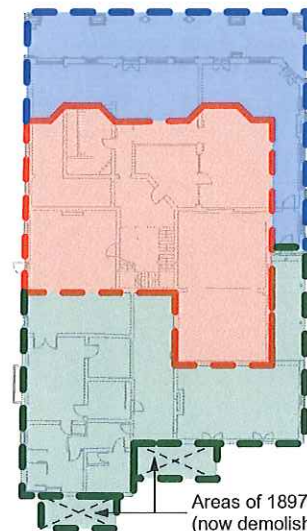
**Key - Assumed Sequence of Developments**

1885/86 - Original Building

1897 - Extension

1914/15 - Extension

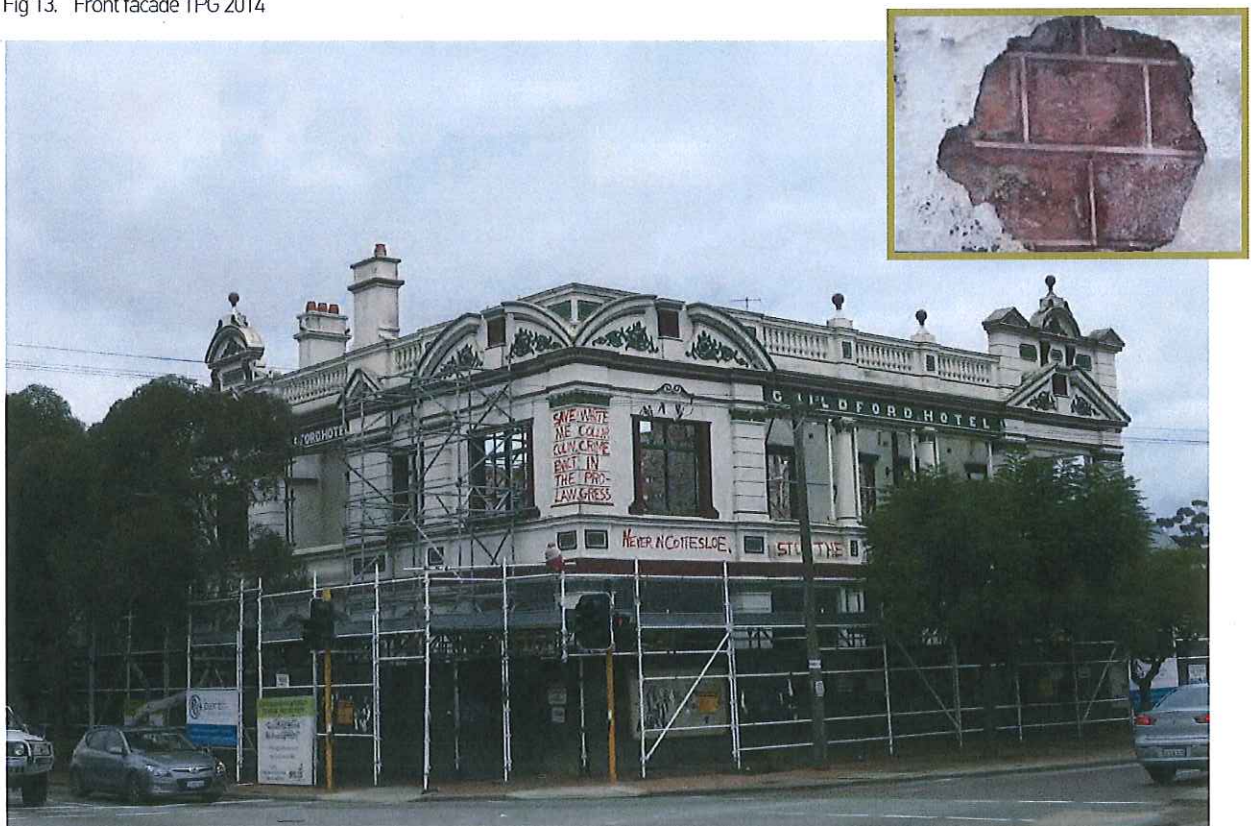
Fig 14. View of James and Johnson street Intersection TPG 2014, inset showing evidence of original tuckpointing TPG 2014
